PROJECT MANUAL VOLUME 3 WELDON AUDITORIUM RENOVATIONS

Manning, South Carolina
Architect's Project No. 21-0024
County's Project No. ITB 2024-014

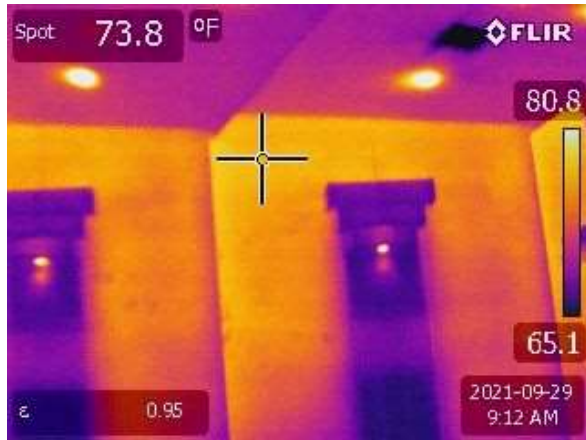
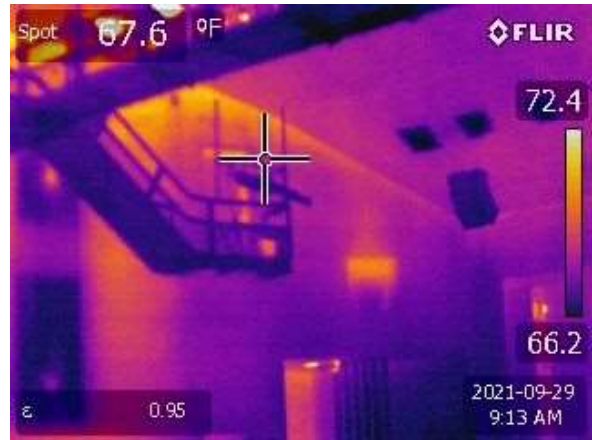
Photos 8-9: IR Photos at interior of south-facing exterior wall

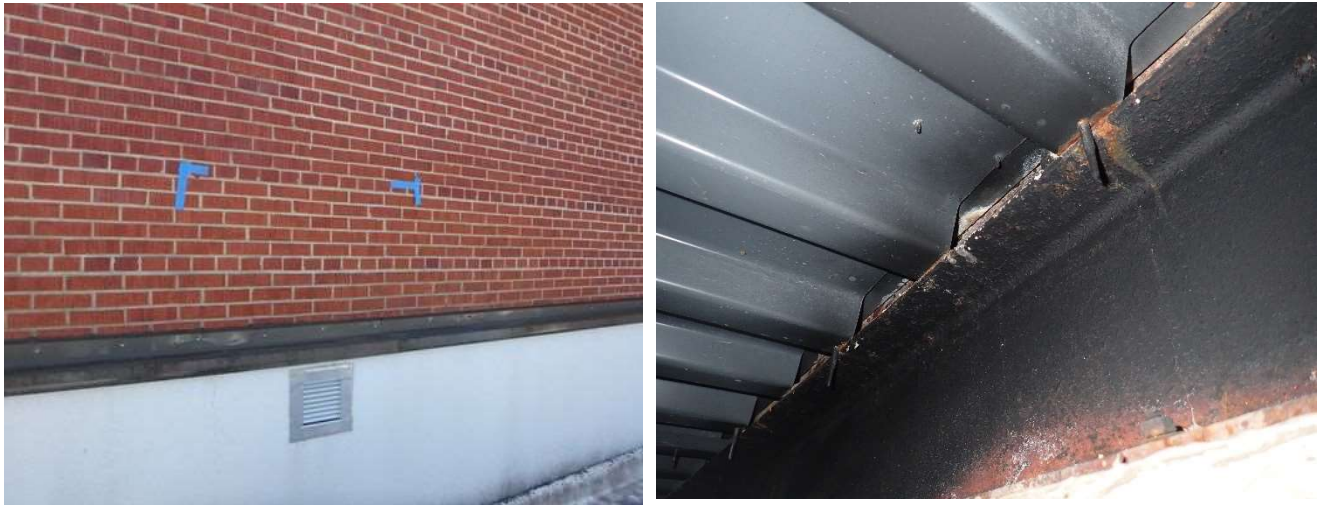
Photos 15-16: Exterior and interior views of ST-1

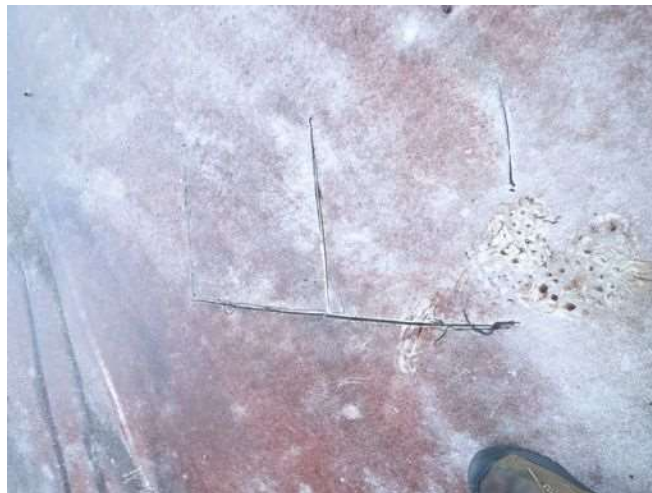
Photo 17: Location of ST-2

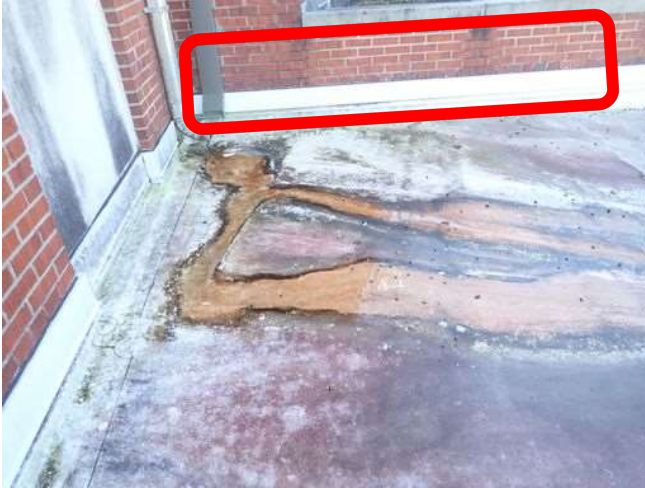
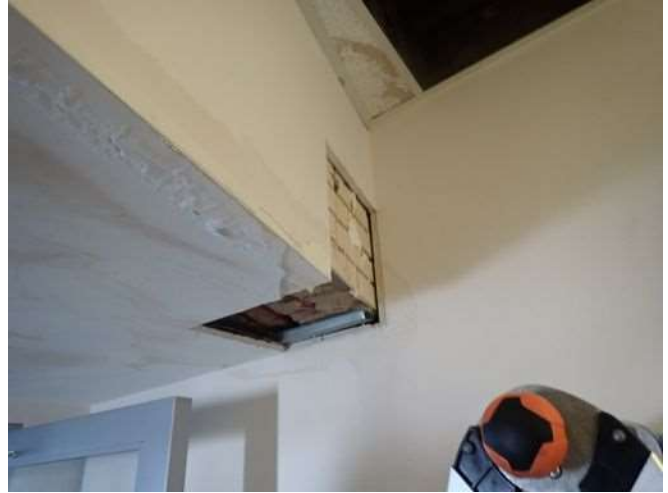
Photos 18-19: Exterior and interior views of ST-3

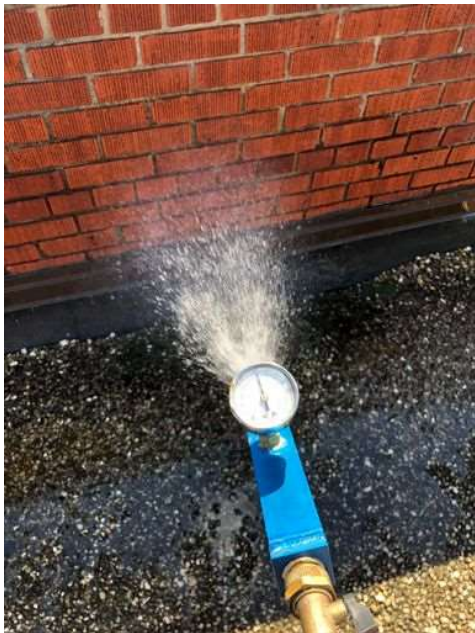
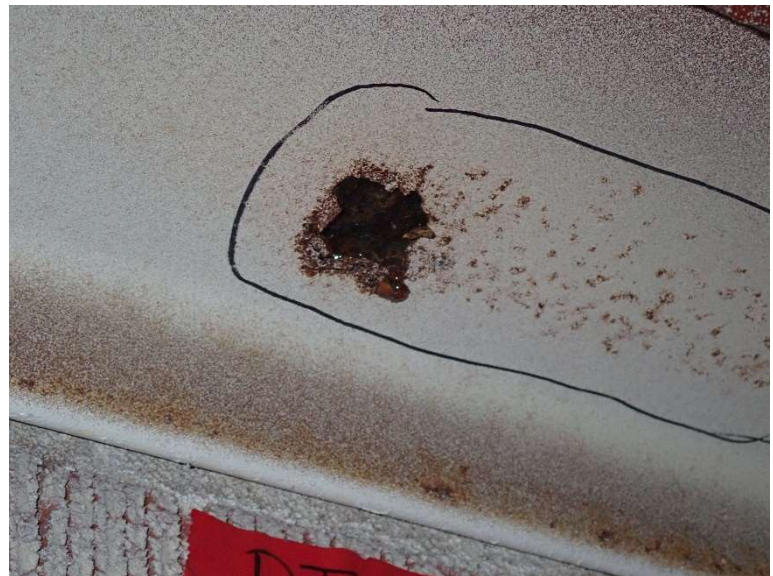
Photos 20-21: Exterior and interior views of ST-4

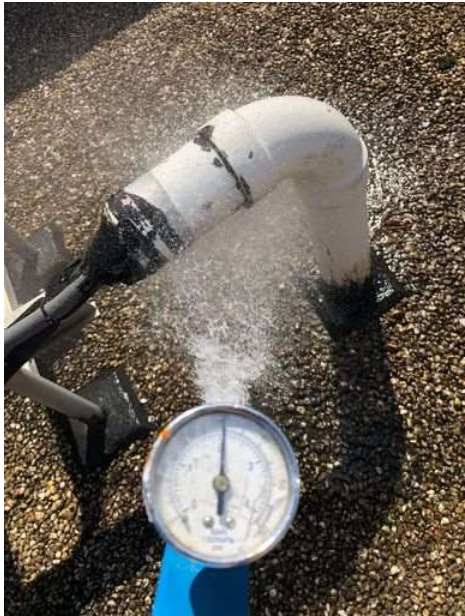
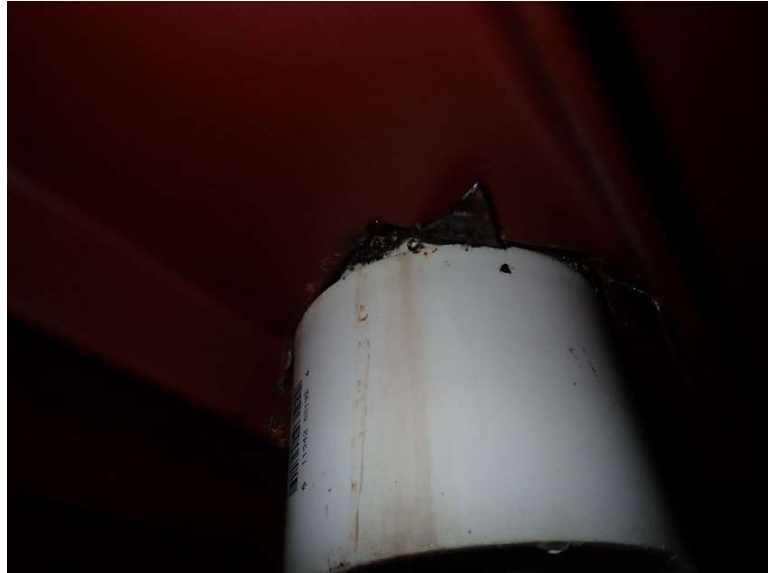
Photos 22-23: Interior and exterior views of ST-5

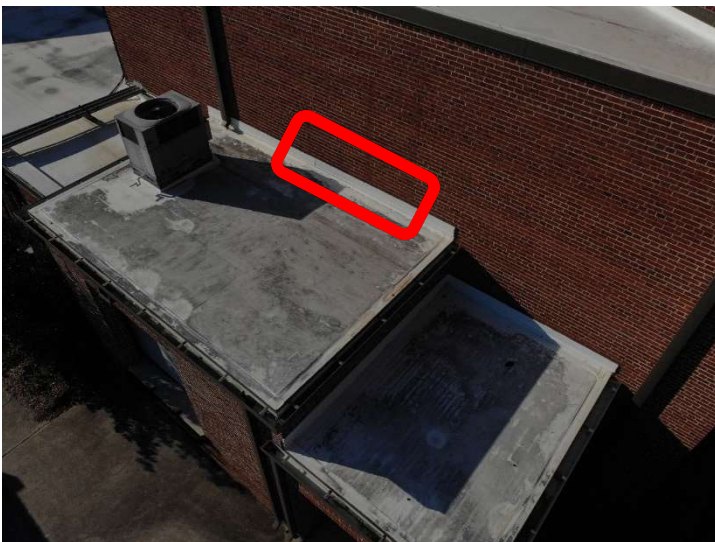
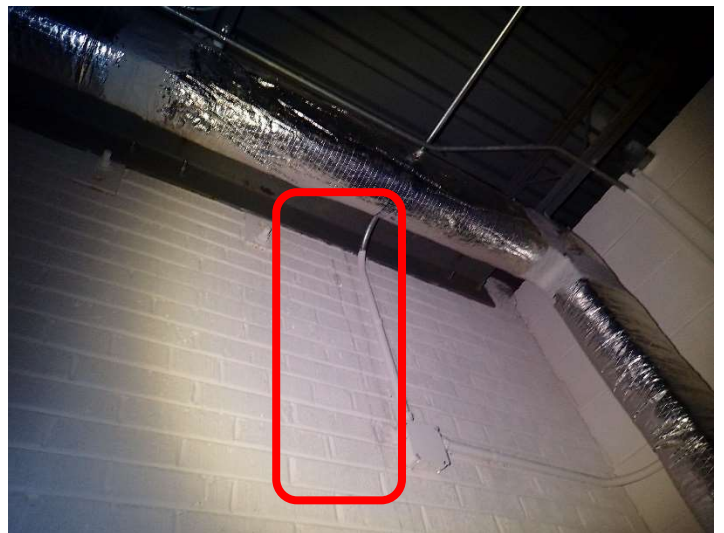
Photos 24-25: Exterior and interior views of ST-6

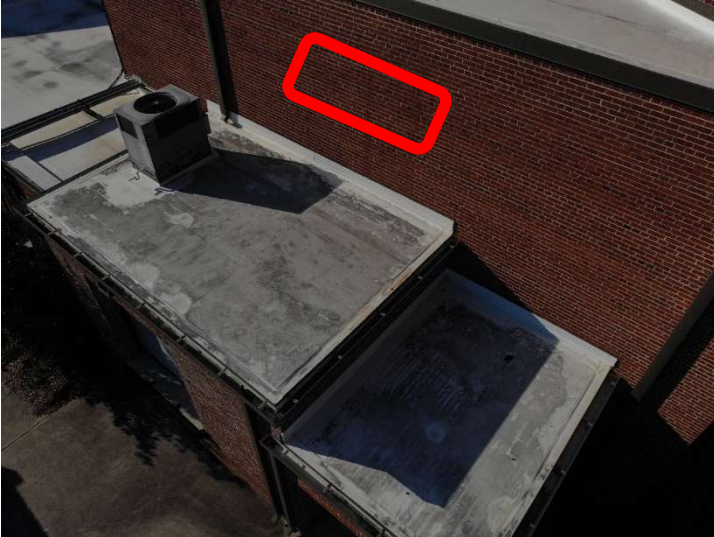
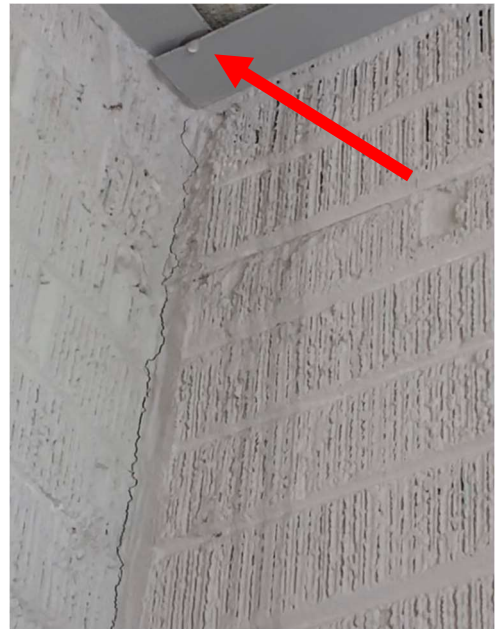
Photos 26-27: Interior and exterior views of ST-7

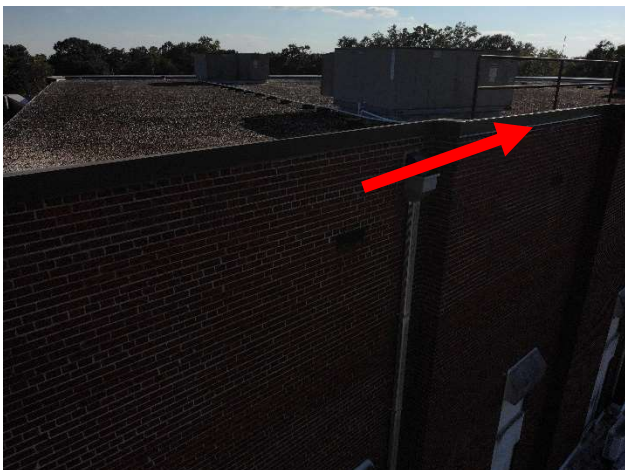
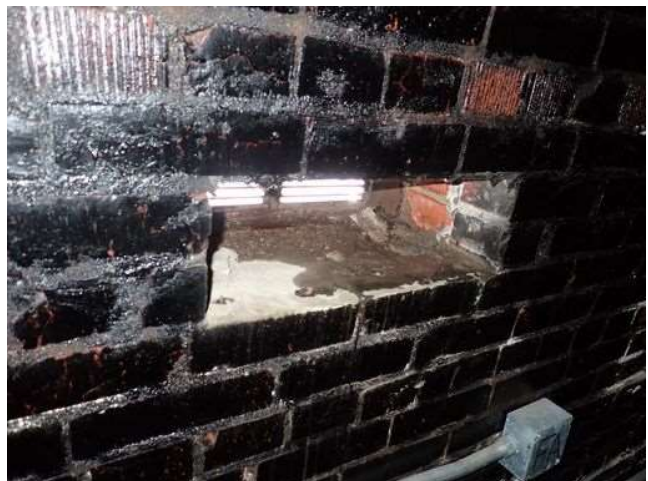
Photos 28-29: Interior and exterior views of ST-8

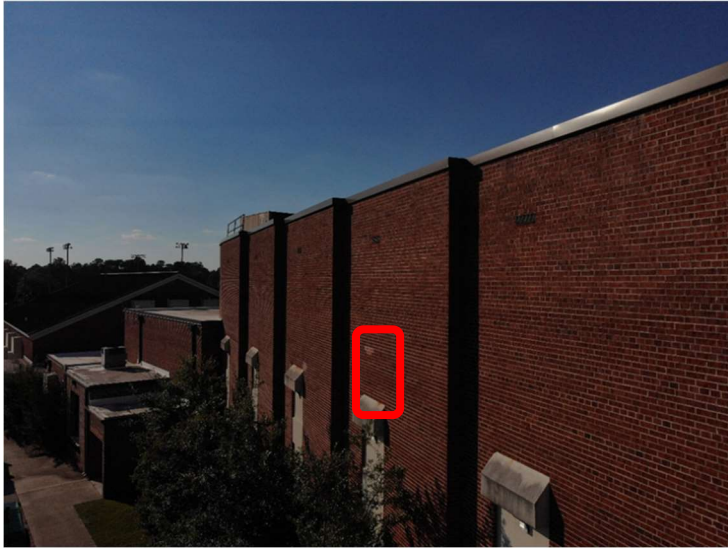
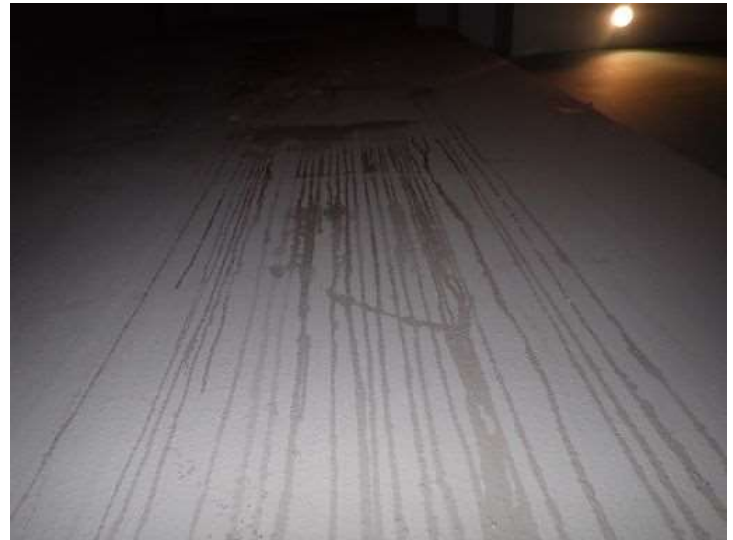
Photos 30-31: Interior and exterior views of ST-9

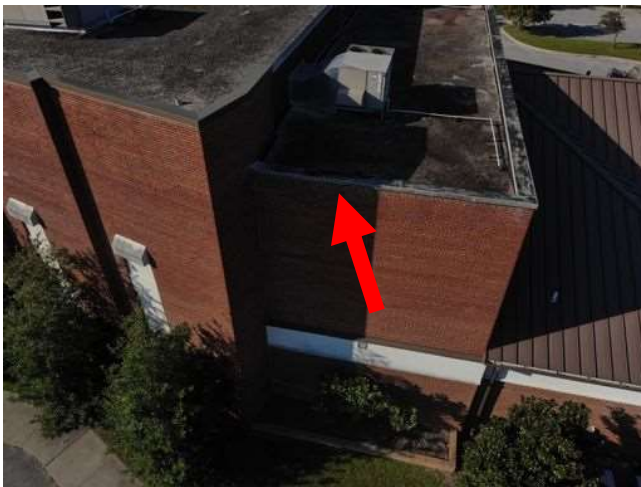
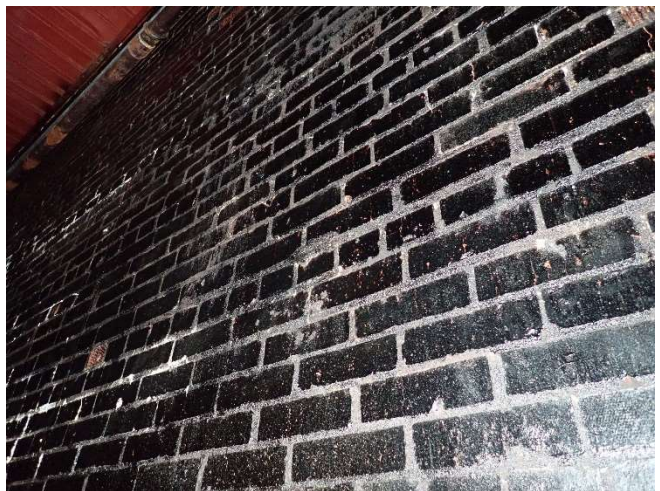
Photos 32-33: Interior and exterior views of ST-10

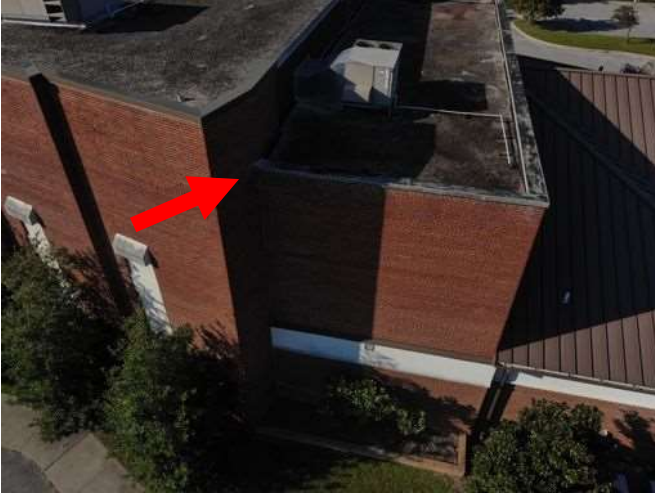
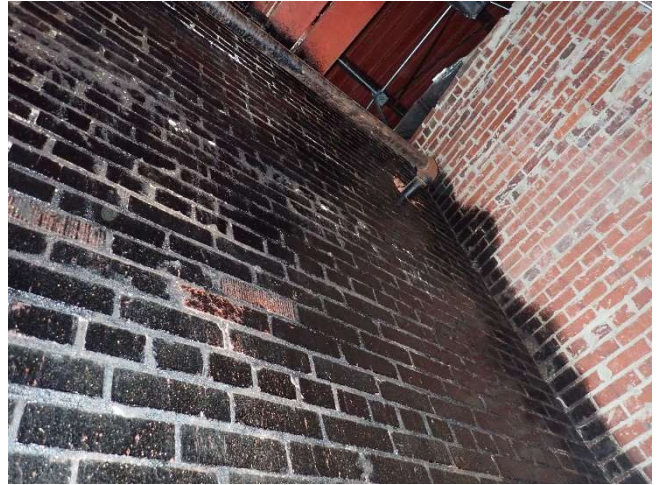
Photos 34-35: Interior and exterior views of ST-11

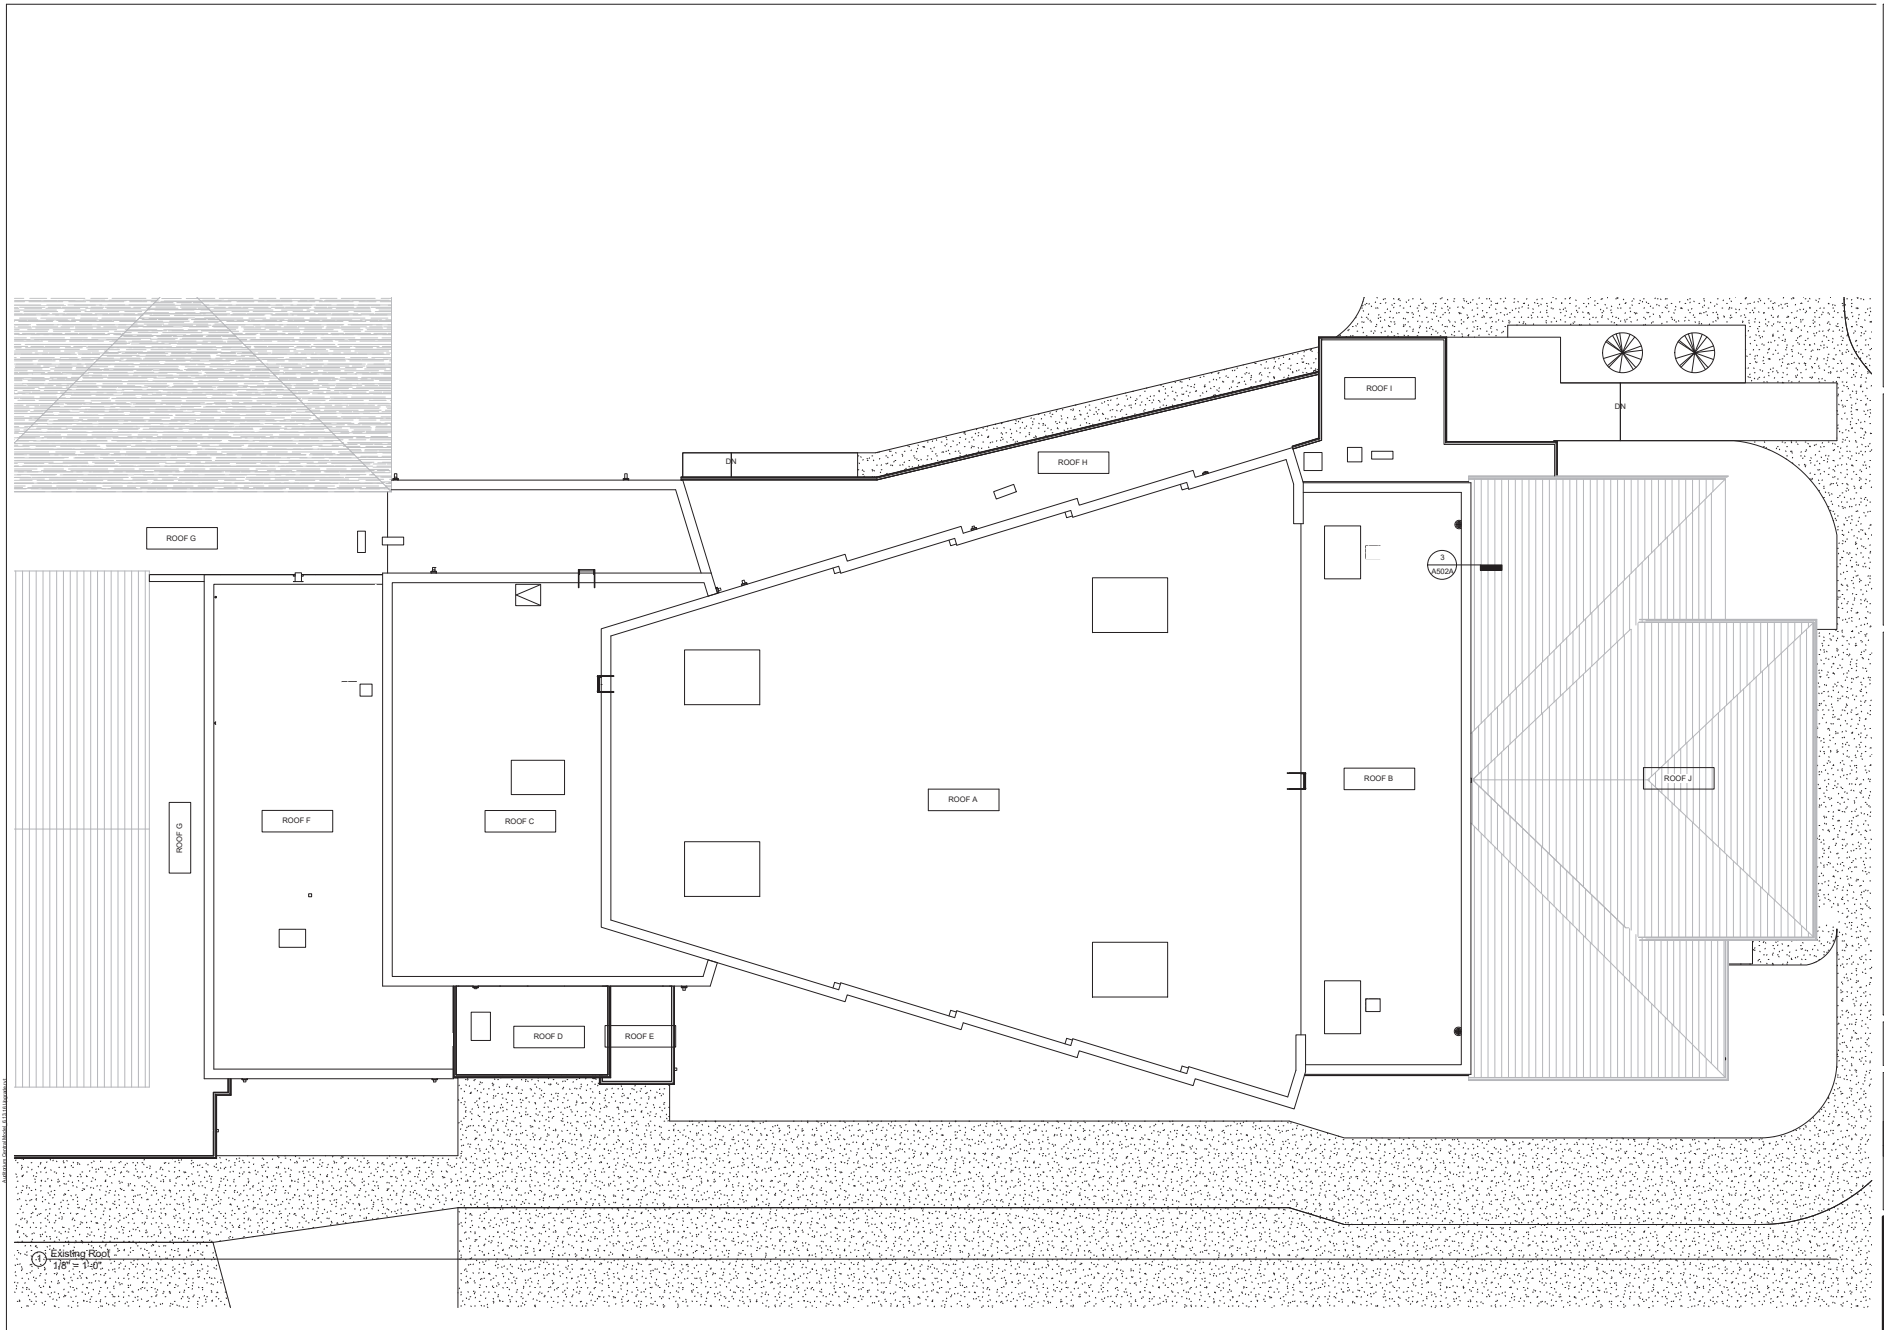
2021 Existing Conditions: Exterior

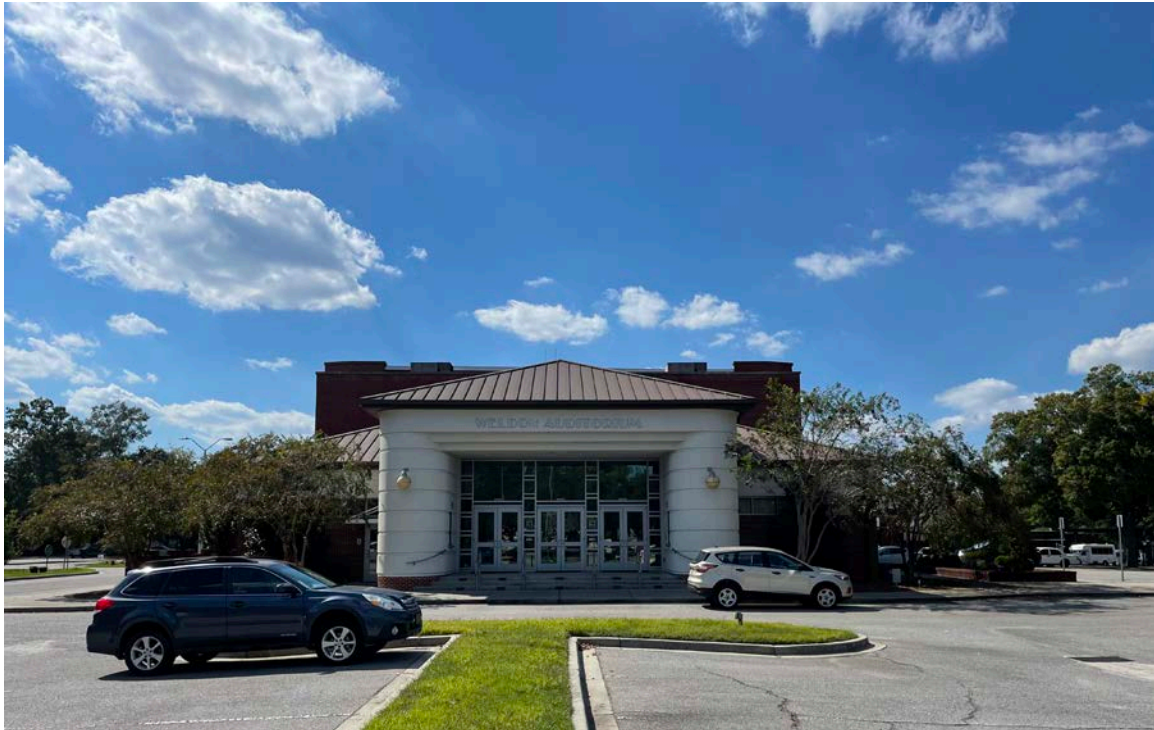
Figure 1: Weldon Auditorium: Overview of the East Front Facade.

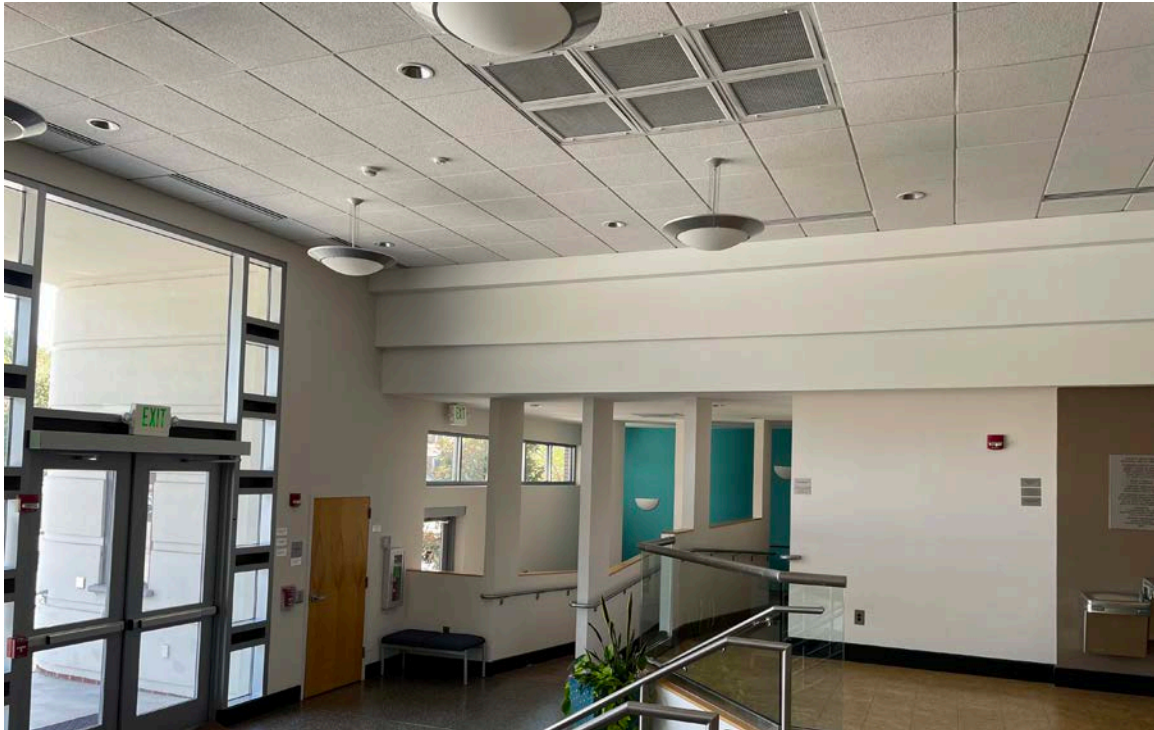
Figure 10: Weldon Auditorium: Overview of the Main Lobby.

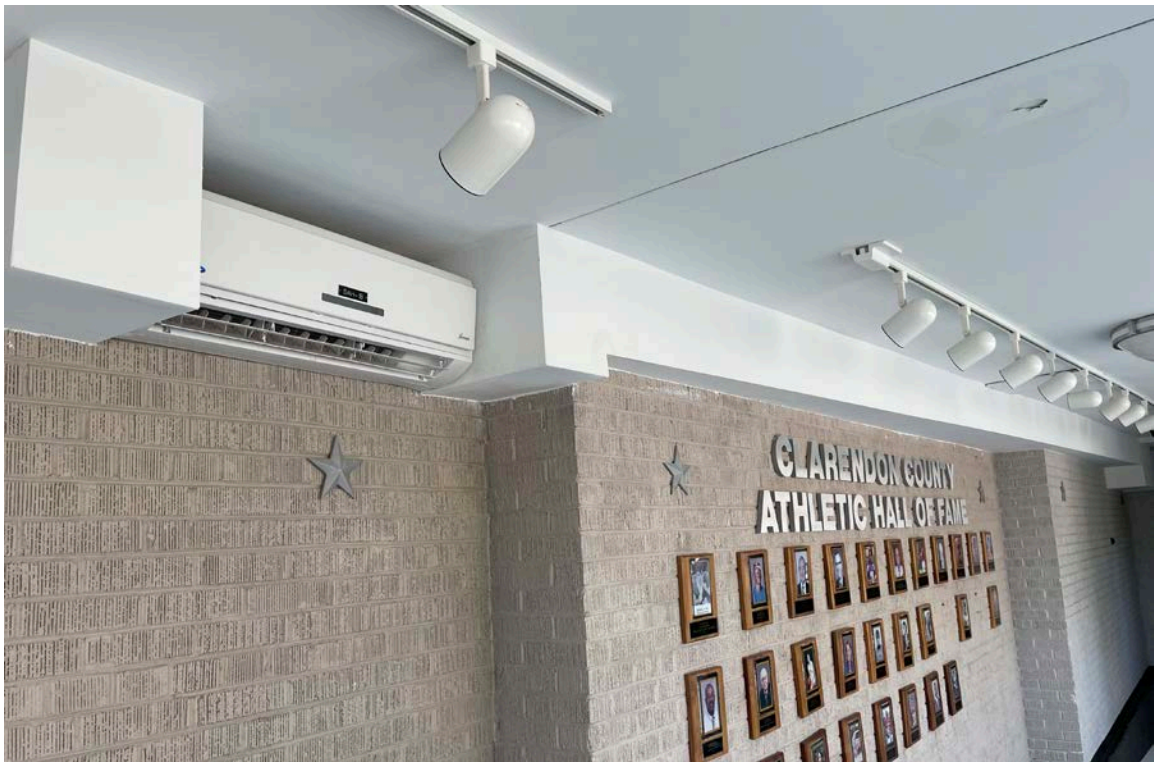
Figure 19: Weldon Auditorium: View of Ceiling Damage in Corridor Looking Southwest.

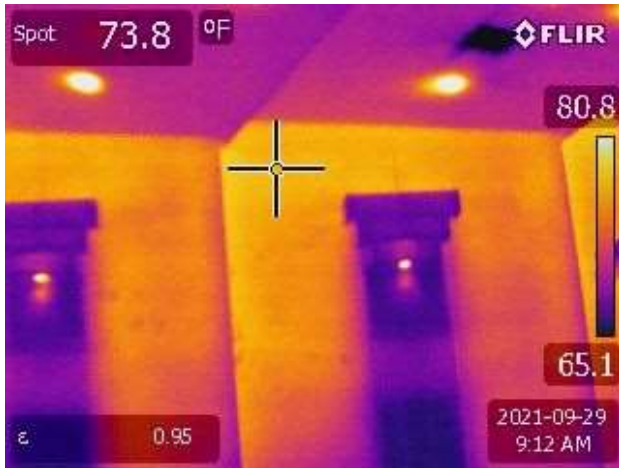
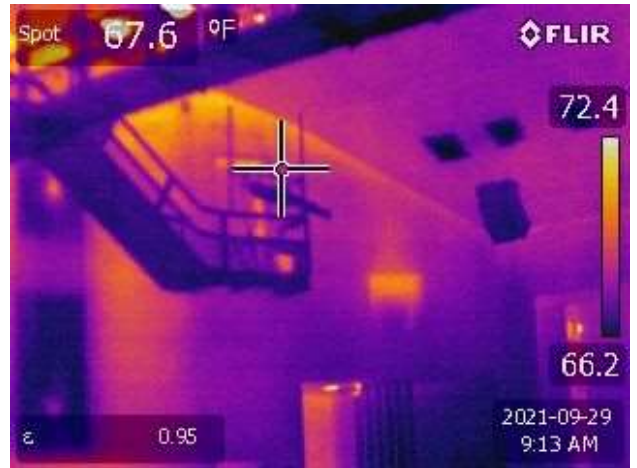
Photos 8-9: IR Photos at interior of south-facing exterior wall

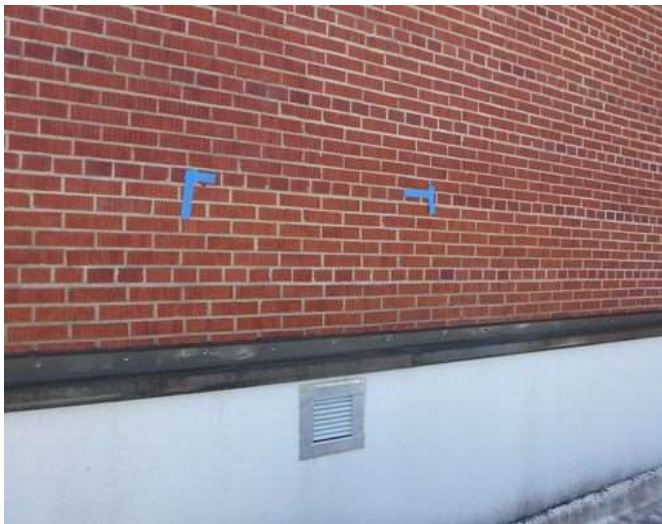
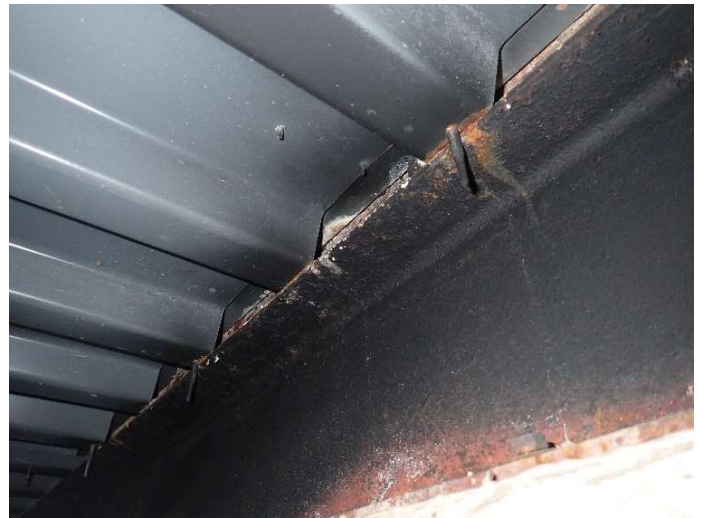
Photos 15-16: Exterior and interior views of ST-1

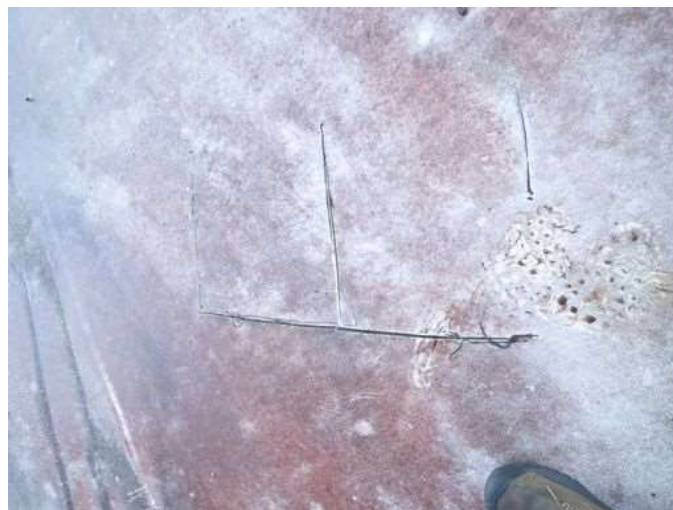
Photo 17: Location of ST-2

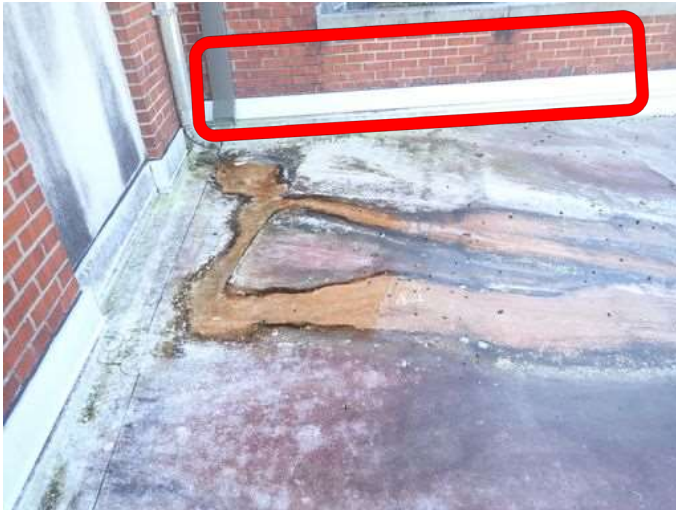
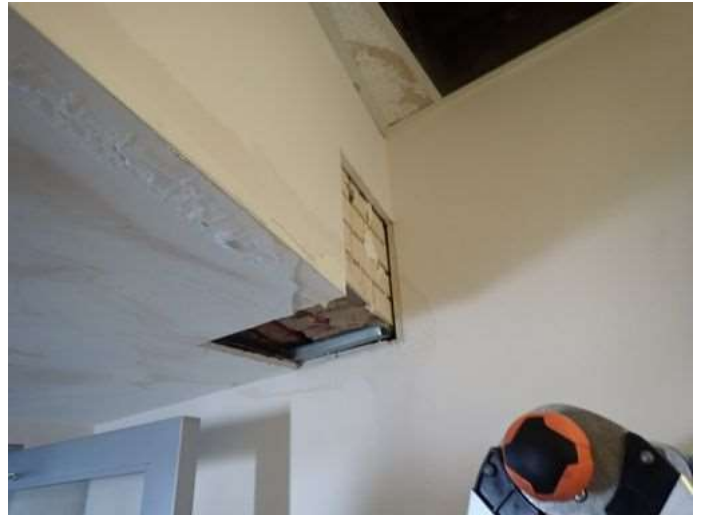
Photos 18-19: Exterior and interior views of ST-3

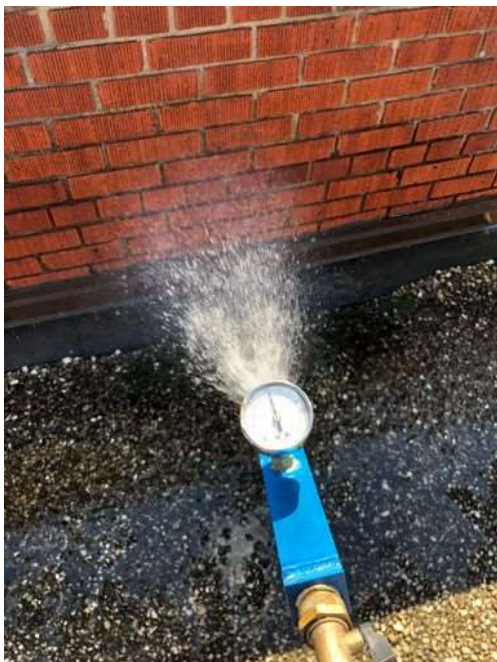
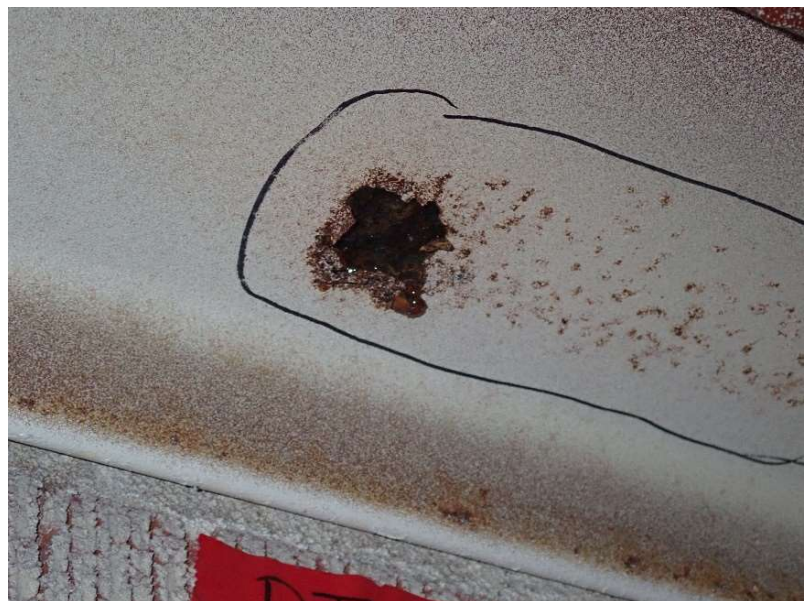
Photos 20-21: Exterior and interior views of ST-4

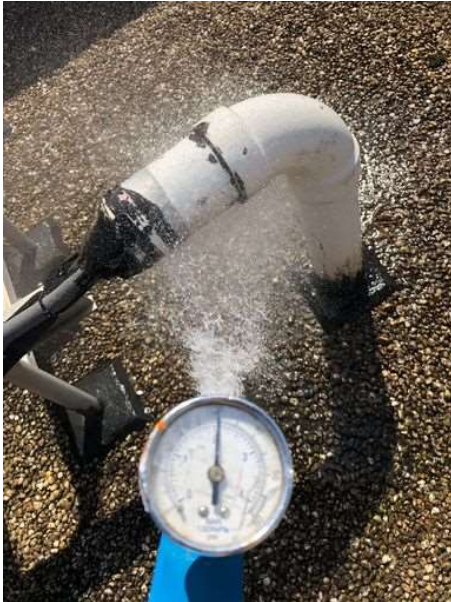
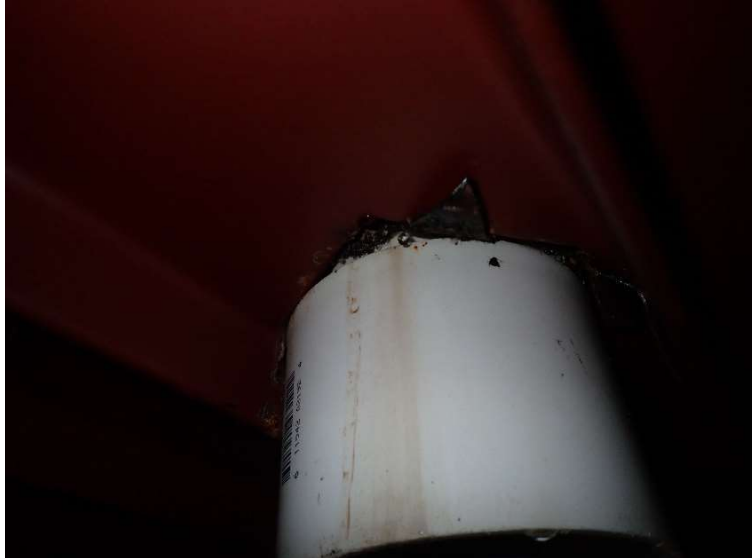
Photos 22-23: Interior and exterior views of ST-5

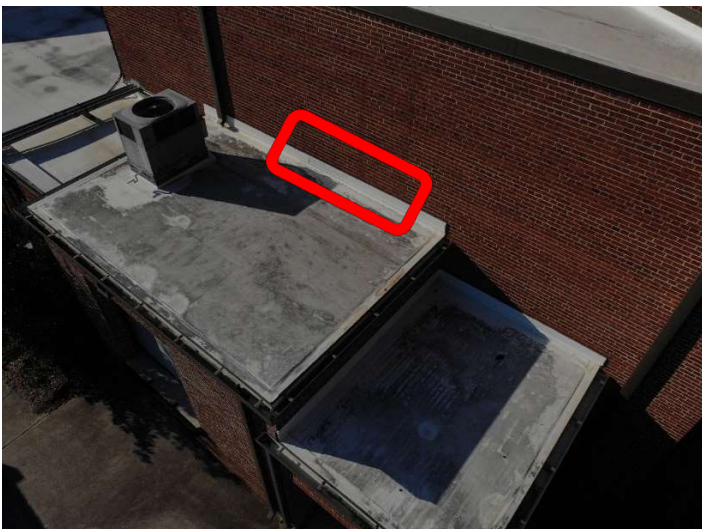
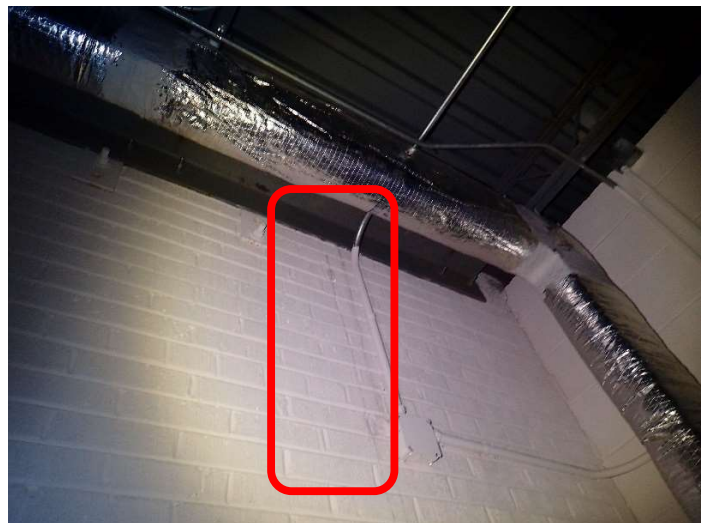
Photos 24-25: Exterior and interior views of ST-6

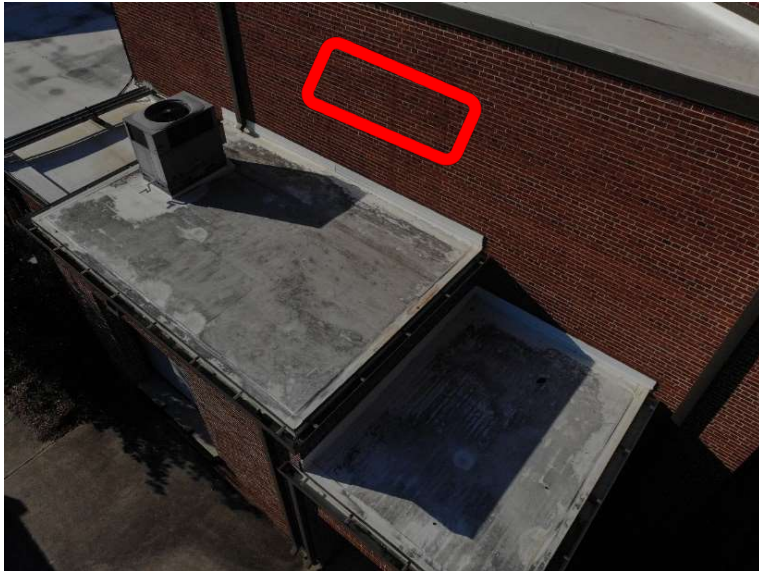
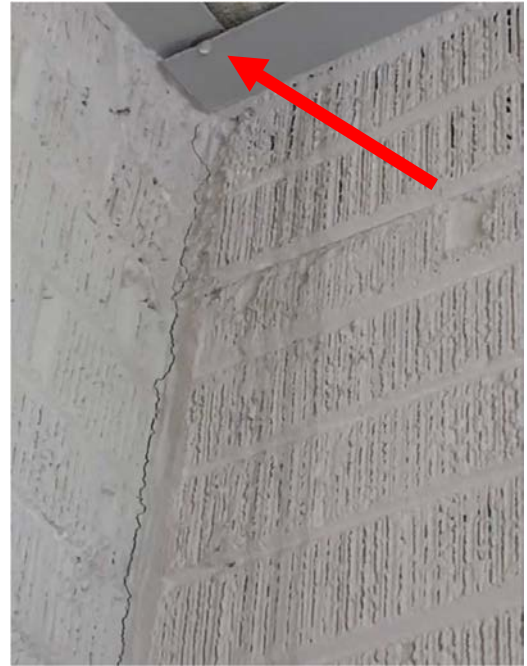
Photos 26-27: Interior and exterior views of ST-7

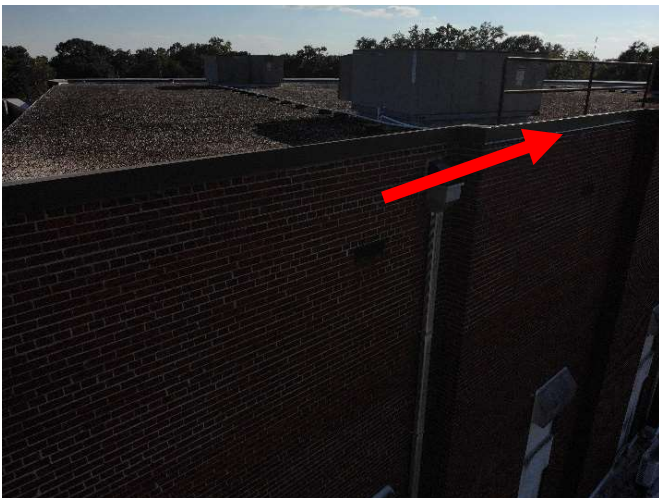
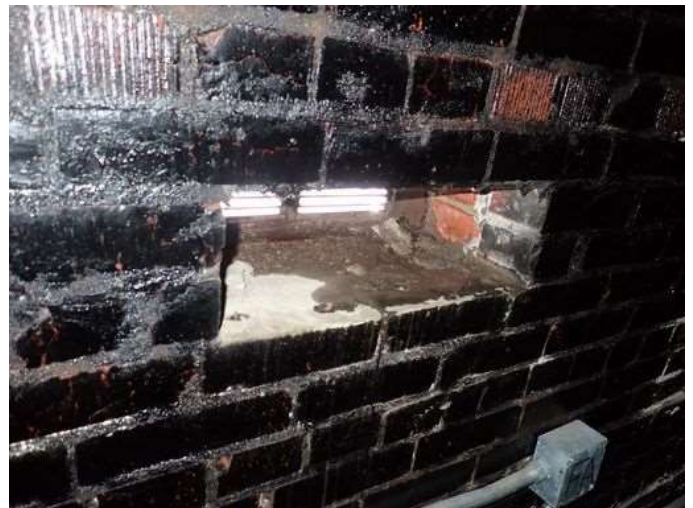
Photos 28-29: Interior and exterior views of ST-8

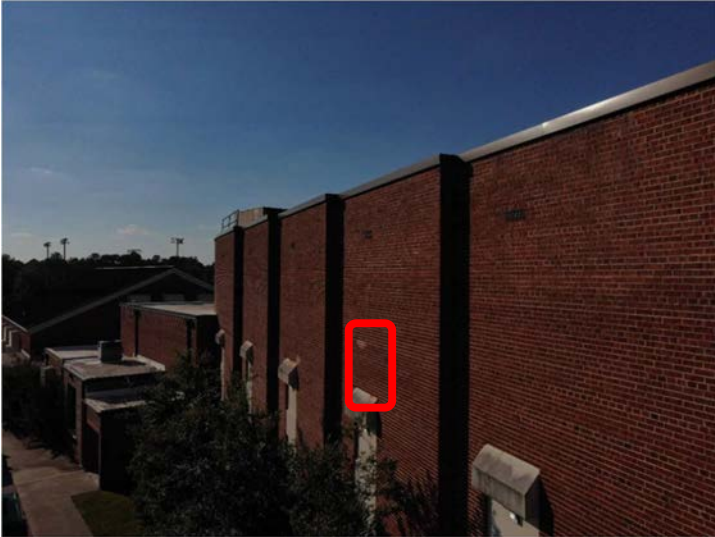
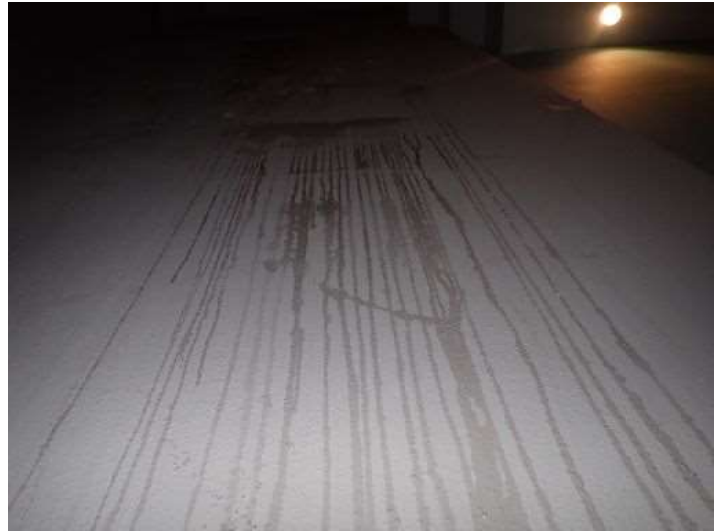
Photos 30-31: Interior and exterior views of ST-9

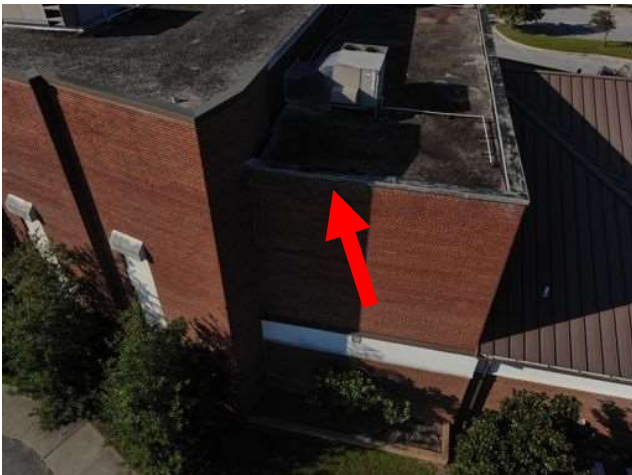
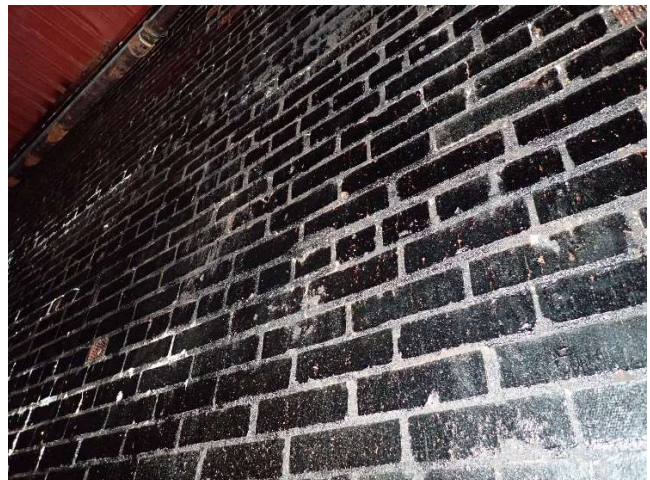
Photos 32-33: Interior and exterior views of ST-10

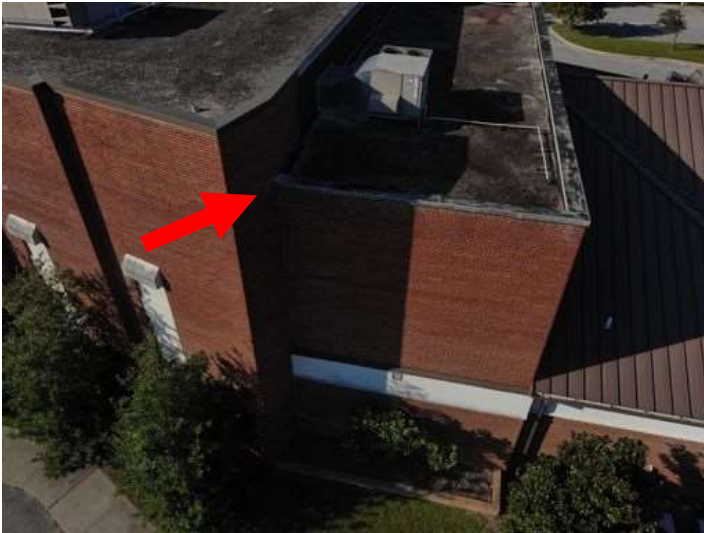
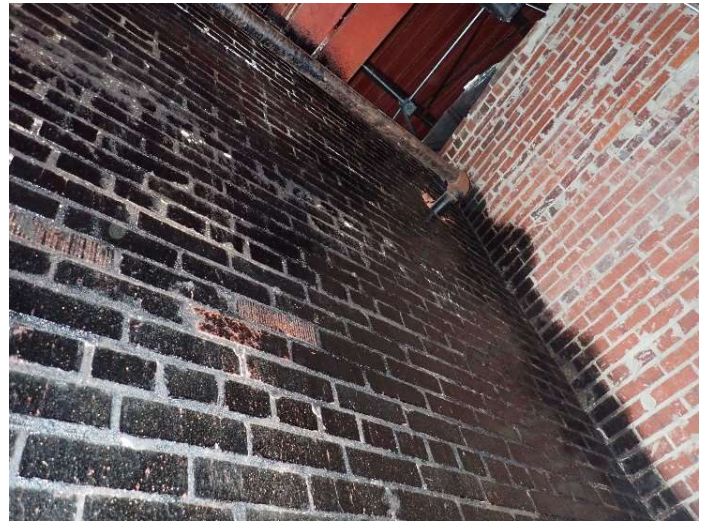
Photos 34-35: Interior and exterior views of ST-11

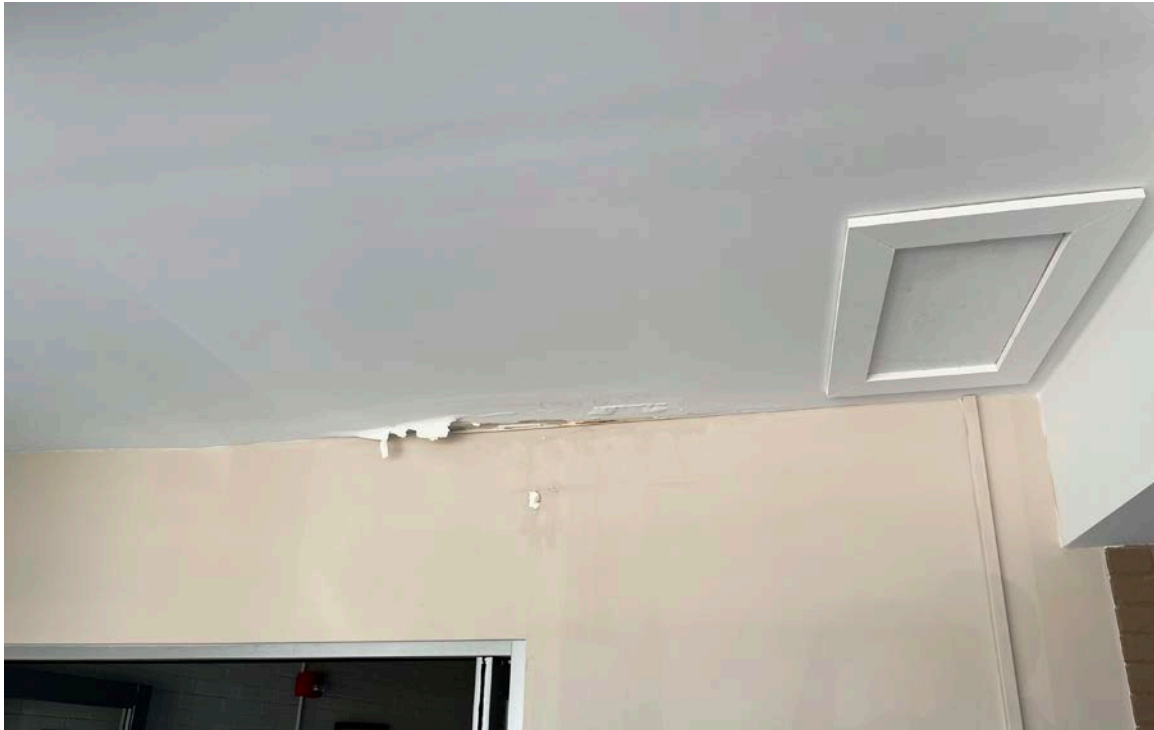
Figure 20: Weldon Auditorium: Hall of fame ceiling damage.

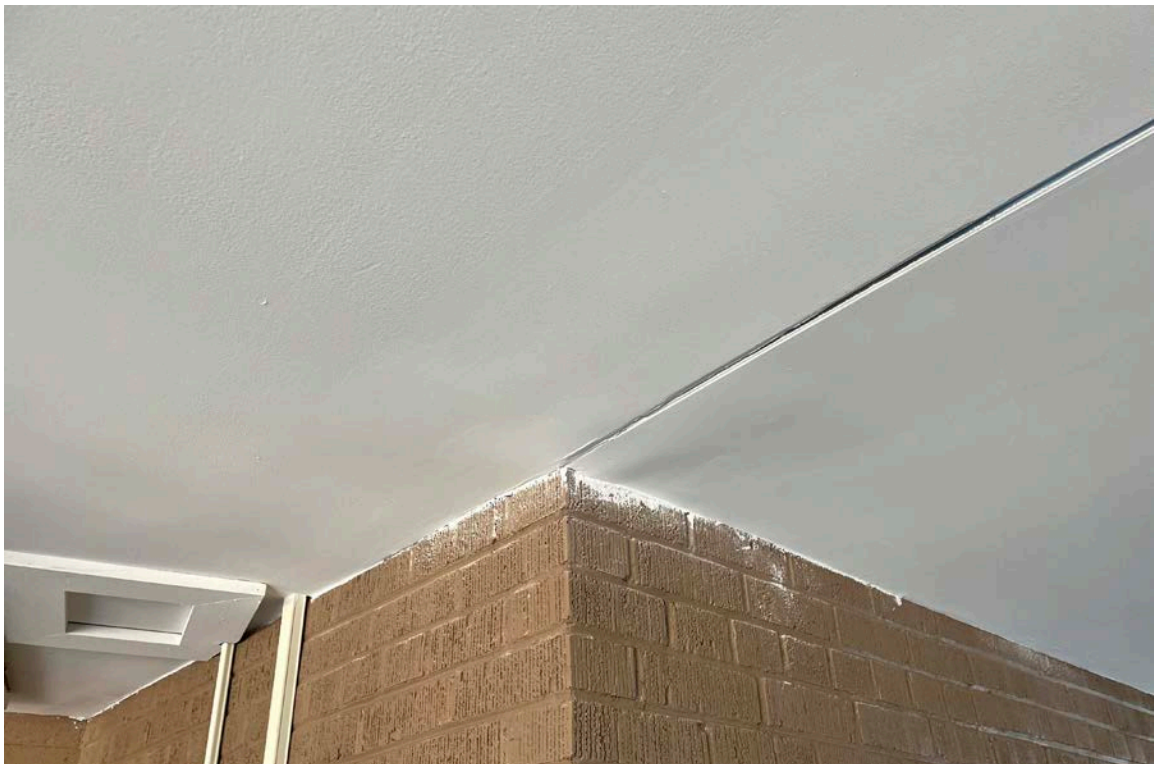
Figure 21: Weldon Auditorium: Damage is present at the intersection of the original auditorium building and the Hall of Fame Addition.
