PROJECT MANUAL VOLUME 3 WELDON AUDITORIUM RENOVATIONS

Manning, South Carolina
Architect's Project No. 21-0024
County's Project No. ITB 2024-014

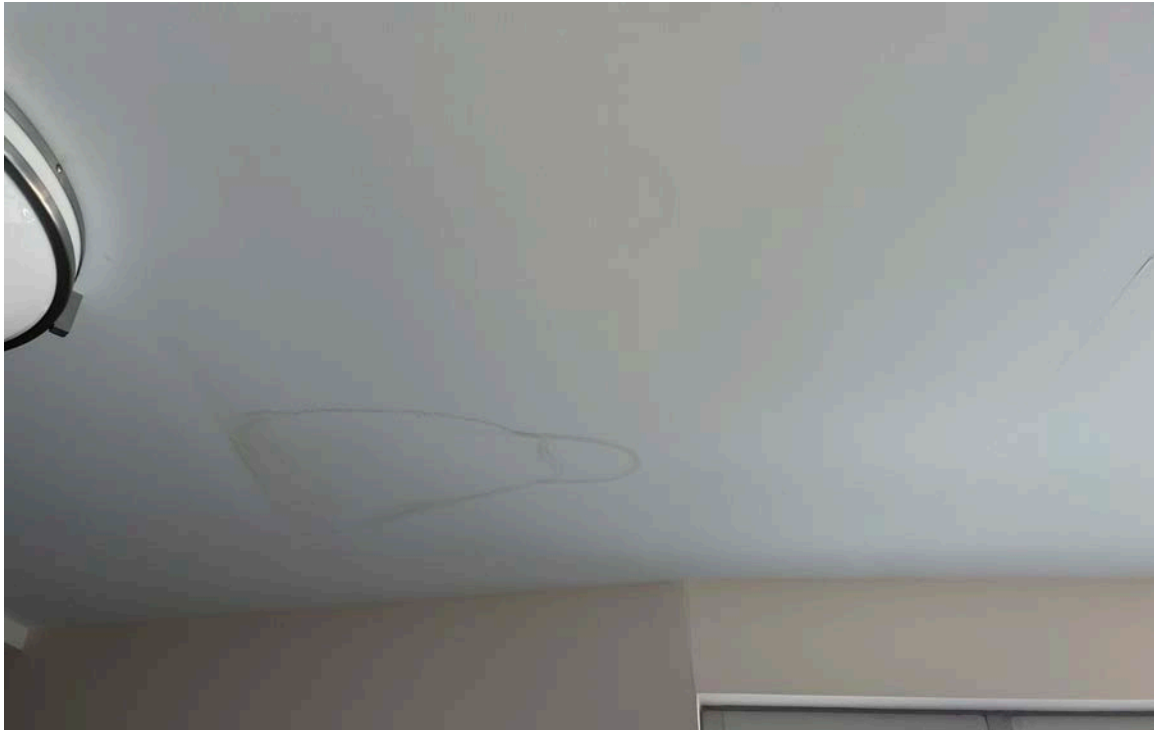
Figure 22: Weldon Auditorium: View of staining within ceiling.

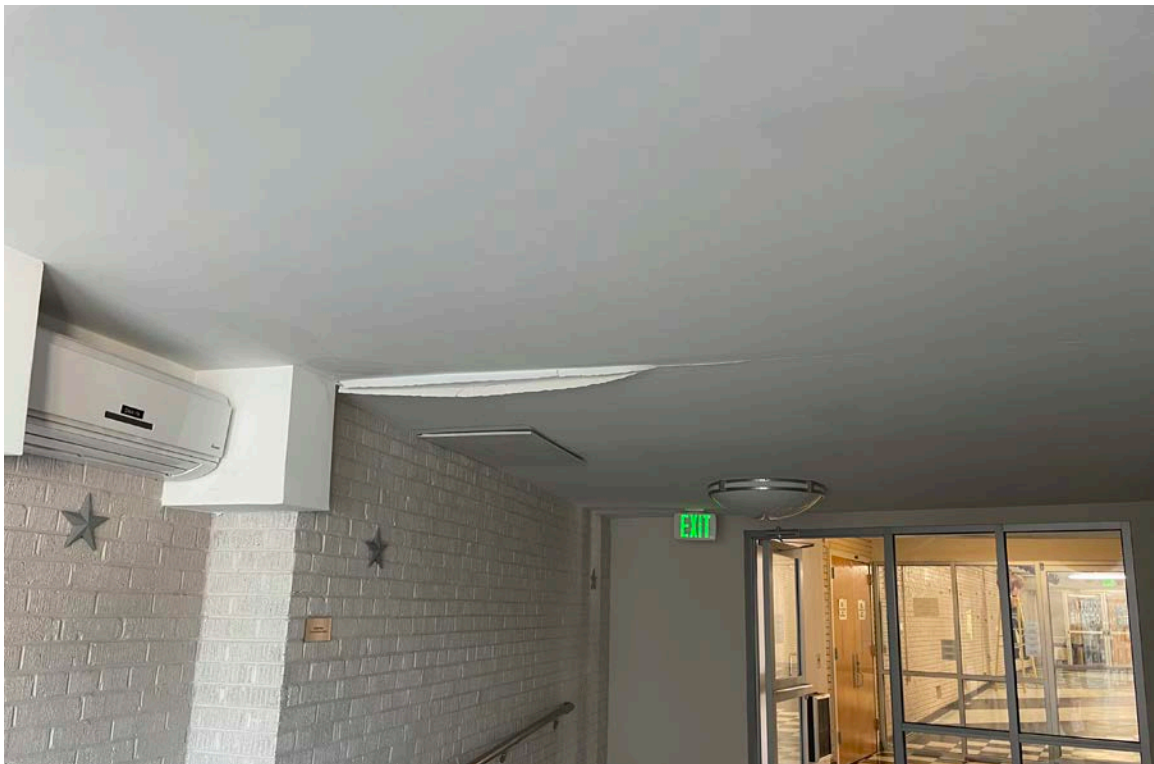
Figure 23: Weldon Auditorium: Detail of drywall tape failure due to moisture intrusion.

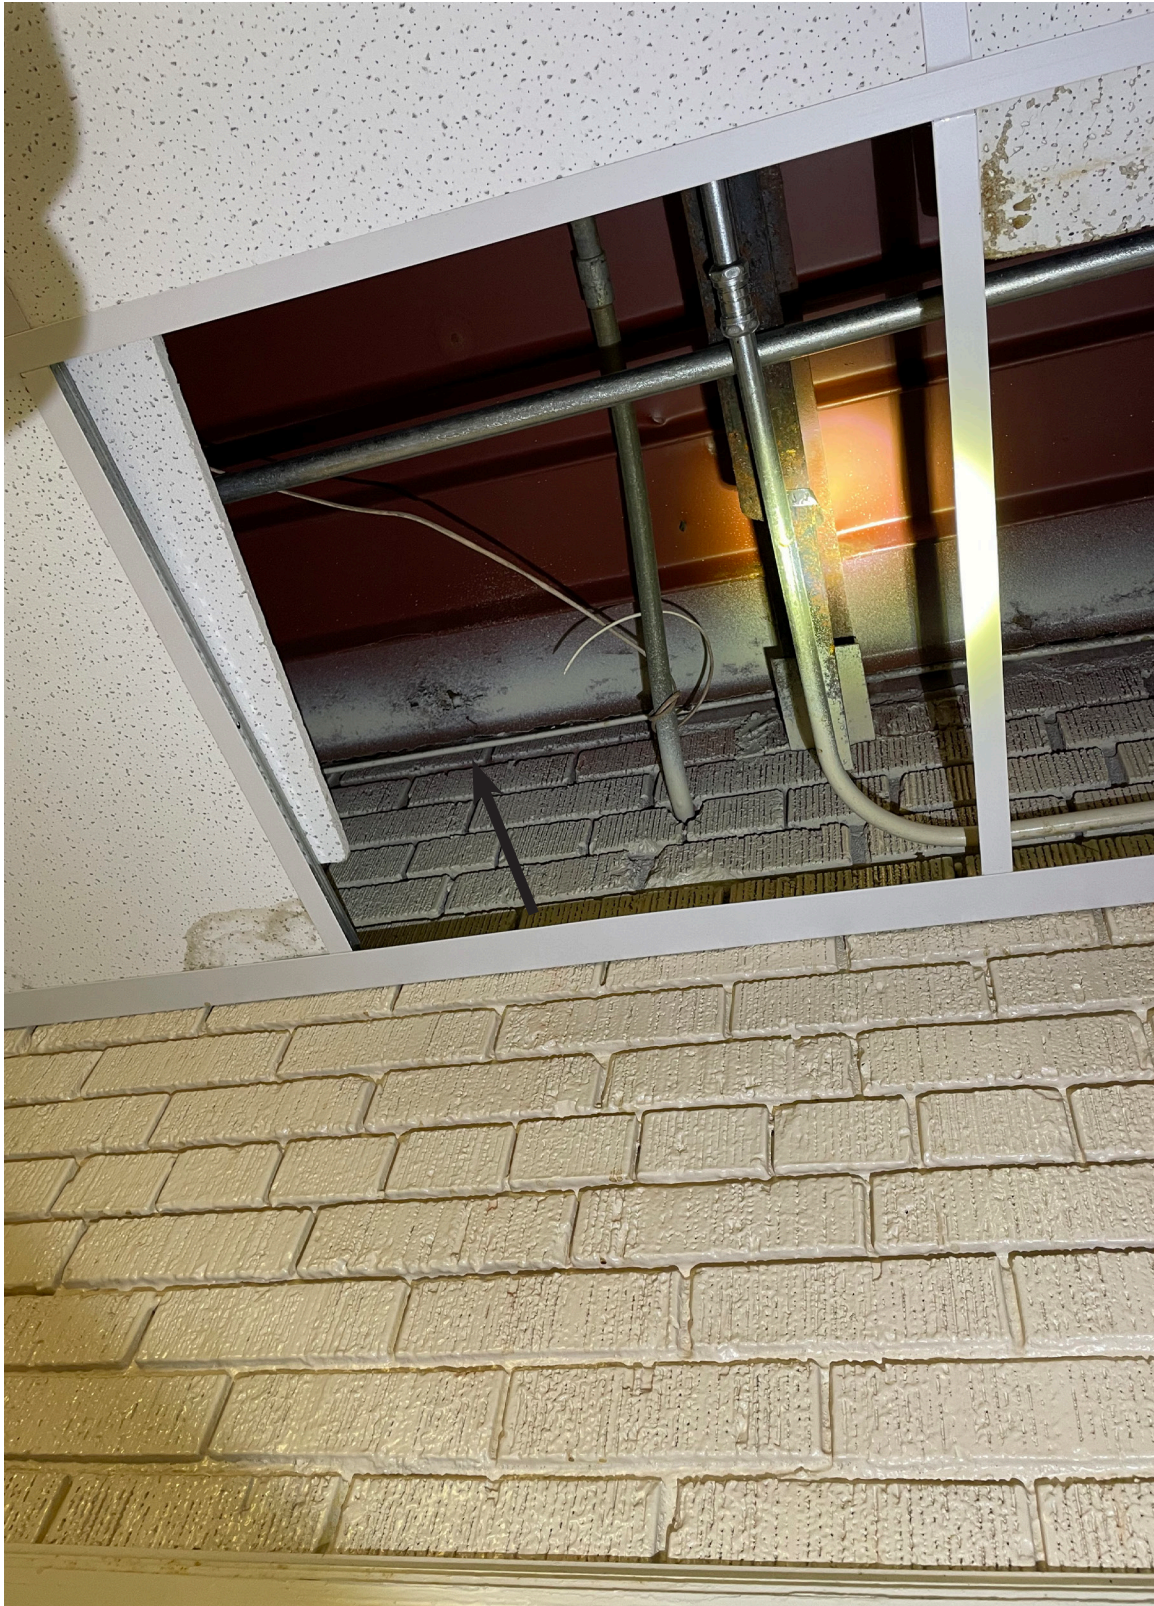
Figure 24: Weldon Auditorium: Detail of corrosion within the decking above the drop tile ceiling.

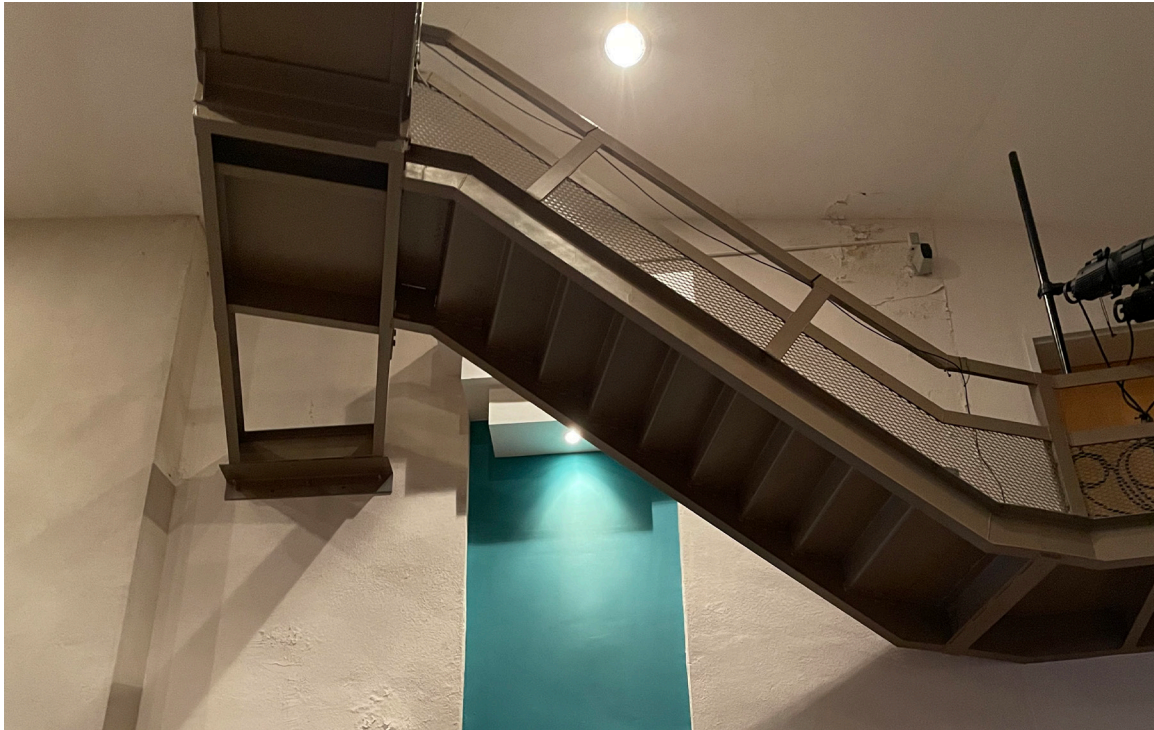
Figure 25: Weldon Auditorium: Overview of the catwalk and ceiling above the stage. Plaster damage is evident along this wall.

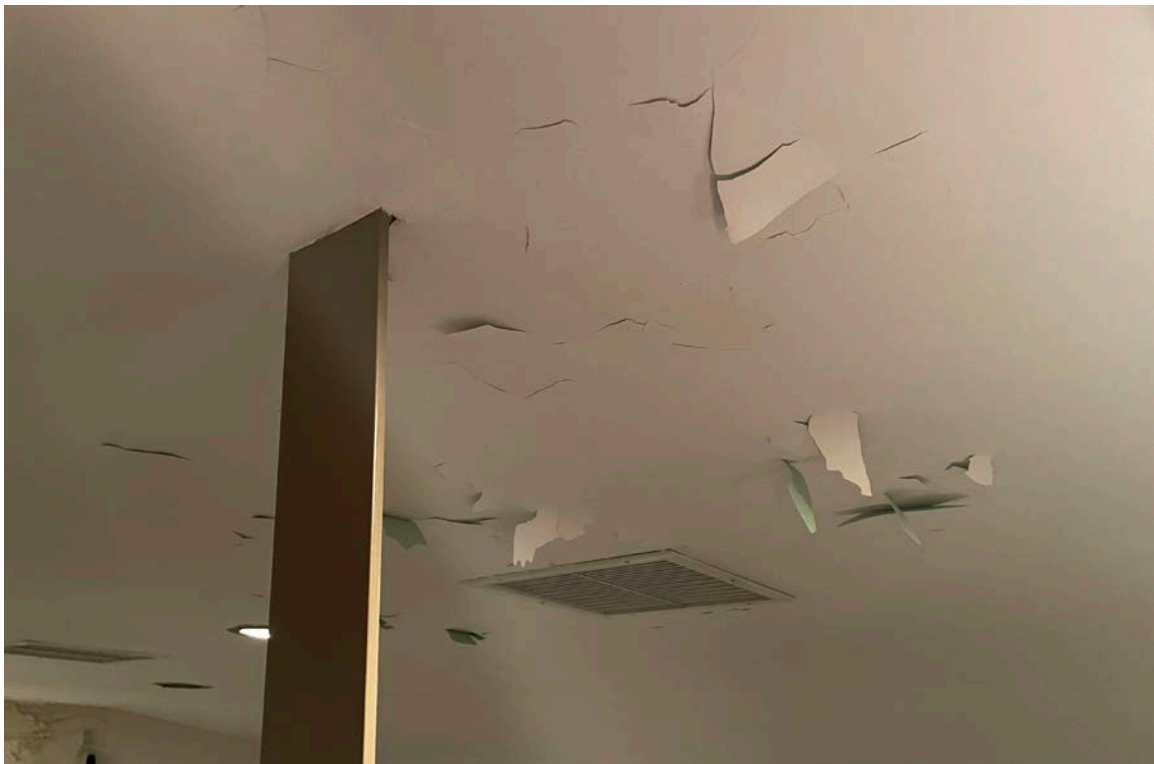
Figure 26: Weldon Auditorium: Detail of ceiling above the catwalk. Note ceiling damage.

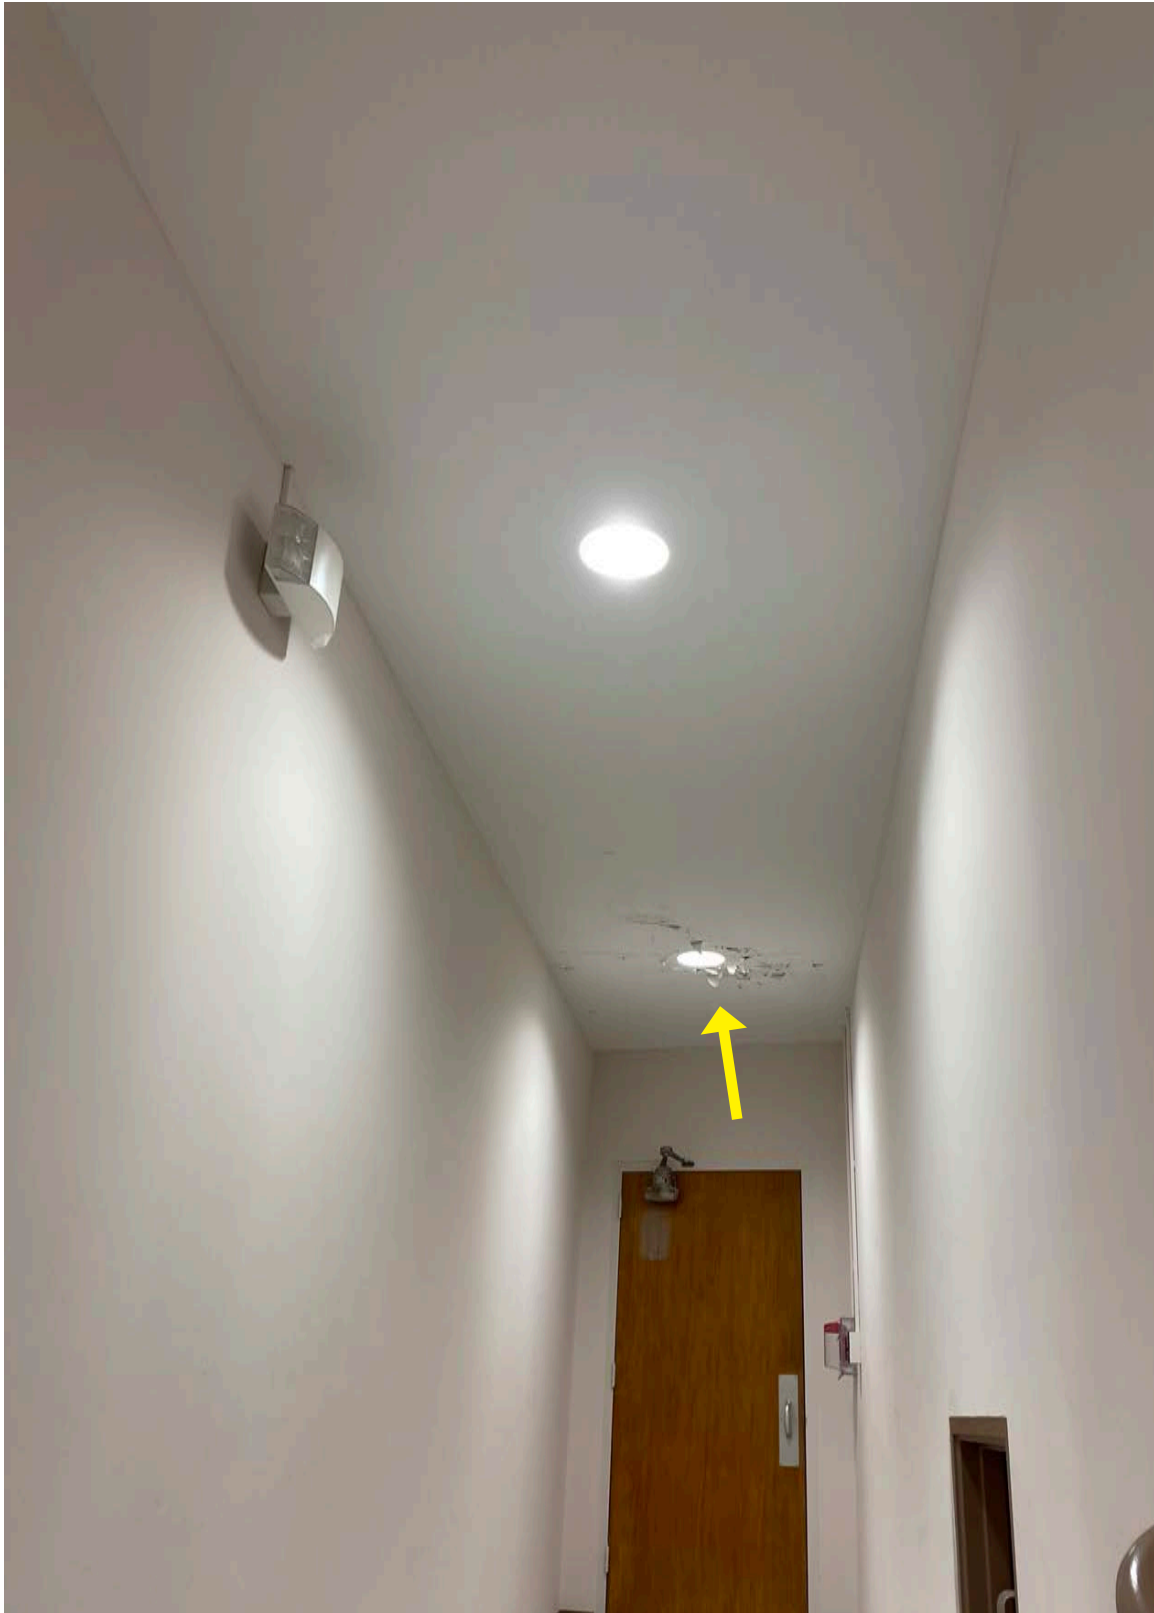
Figure 27: Weldon Auditorium: South stair to balcony. ceiling damage present at the balcony level.

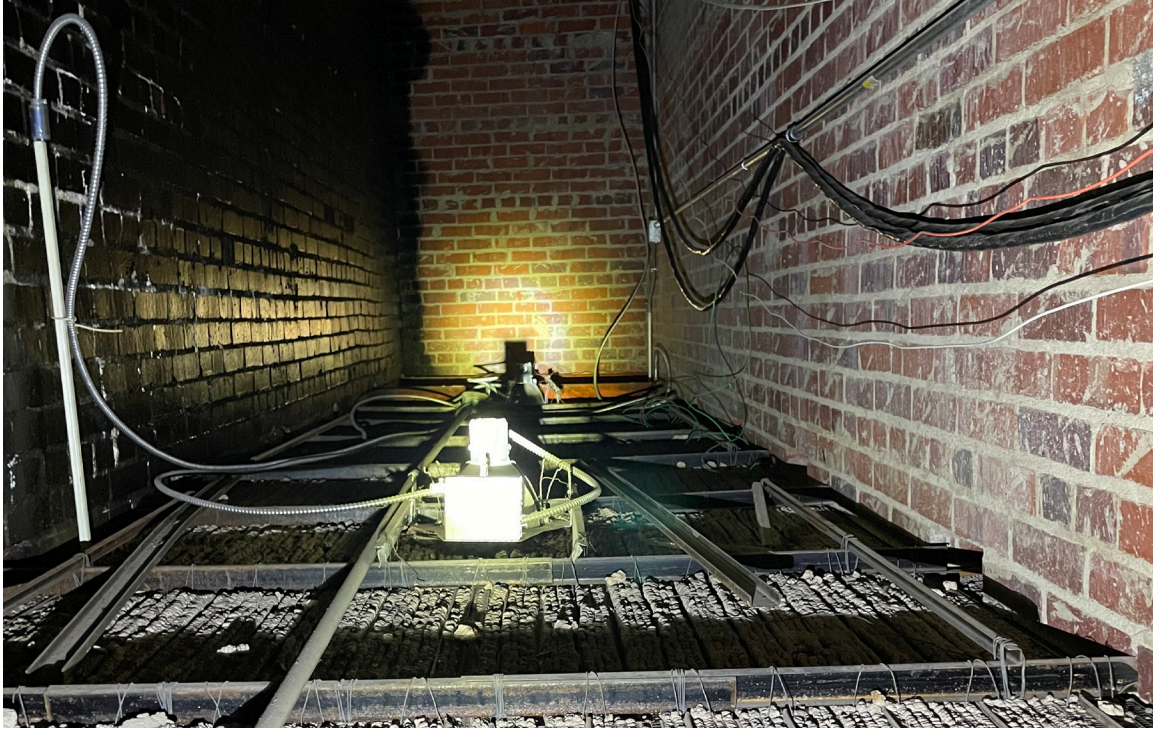
Figure 28: Weldon Auditorium: View above balcony stair ceiling. The exterior masonry wall is at left and has been waterproofed with a black coating. White efflorescence is visible within the mortar joints indicating active water intrusion through the masonry and black coating.

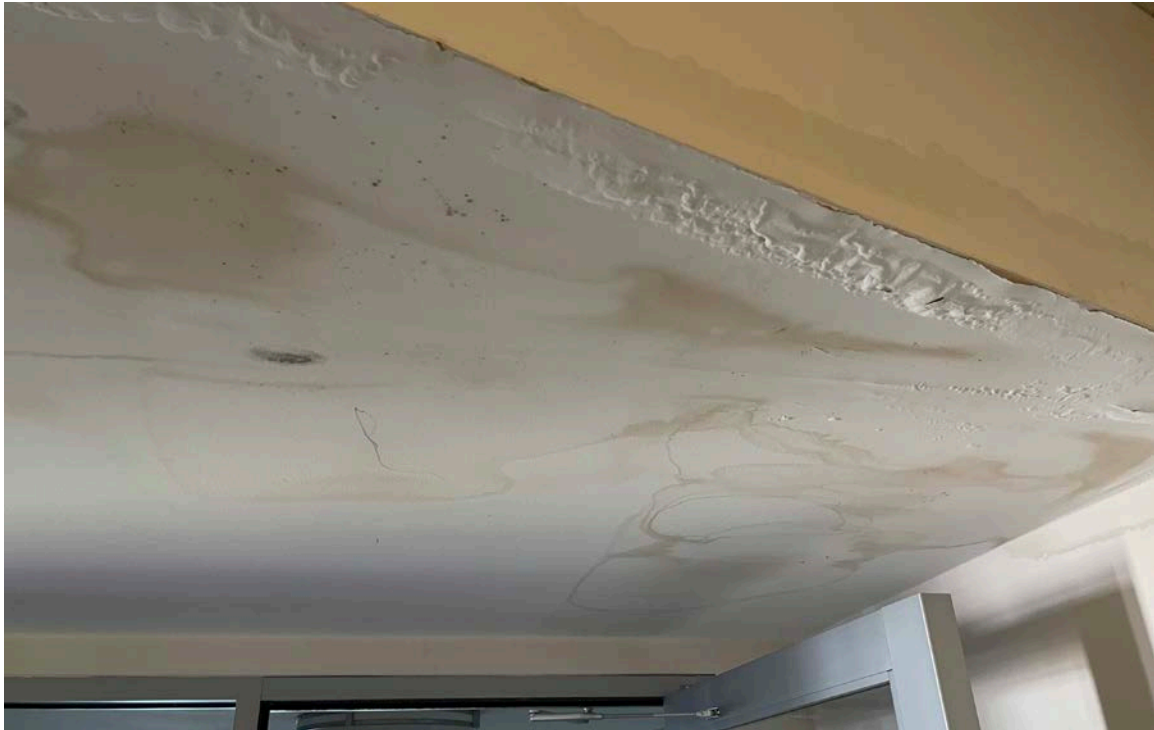
Figure 31: Weldon Auditorium: Detail of the ceiling within the vestibule between the lower and upper galley.

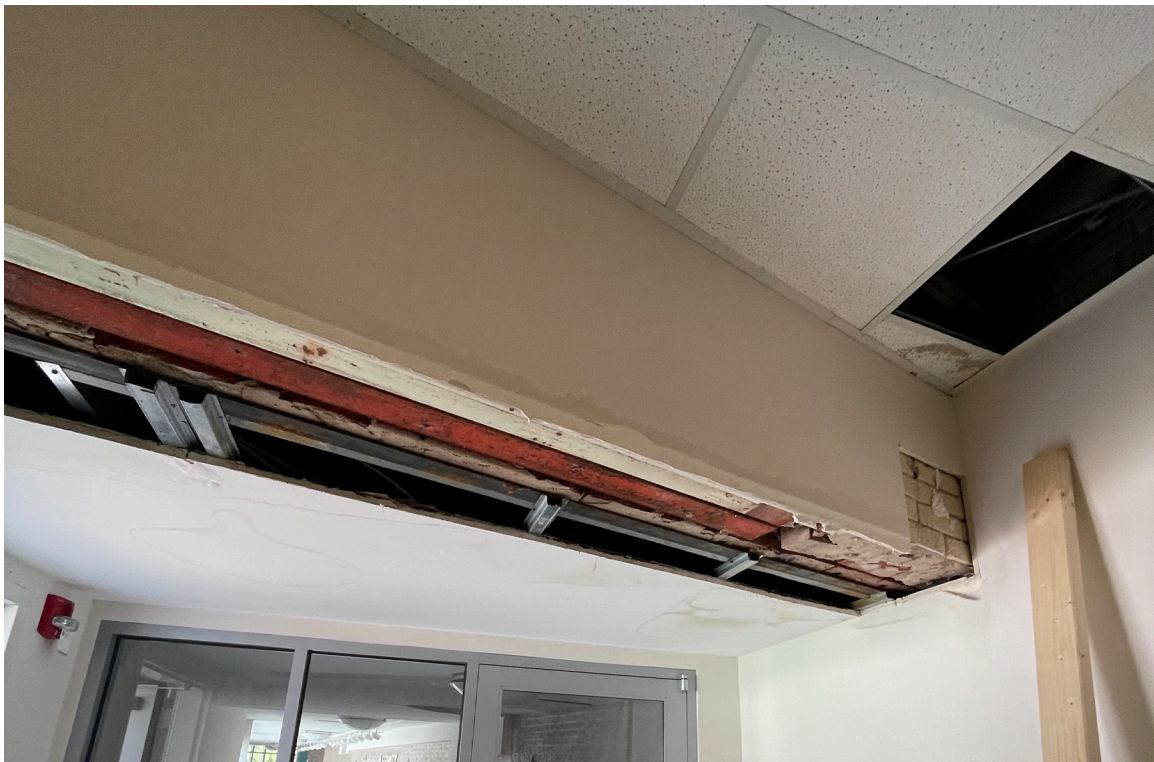
Figure 32: Weldon Auditorium: Detail of masonry following removal of the drywall. The existing steel lintel and masonry were found to be unsupported and were structurally unsafe.

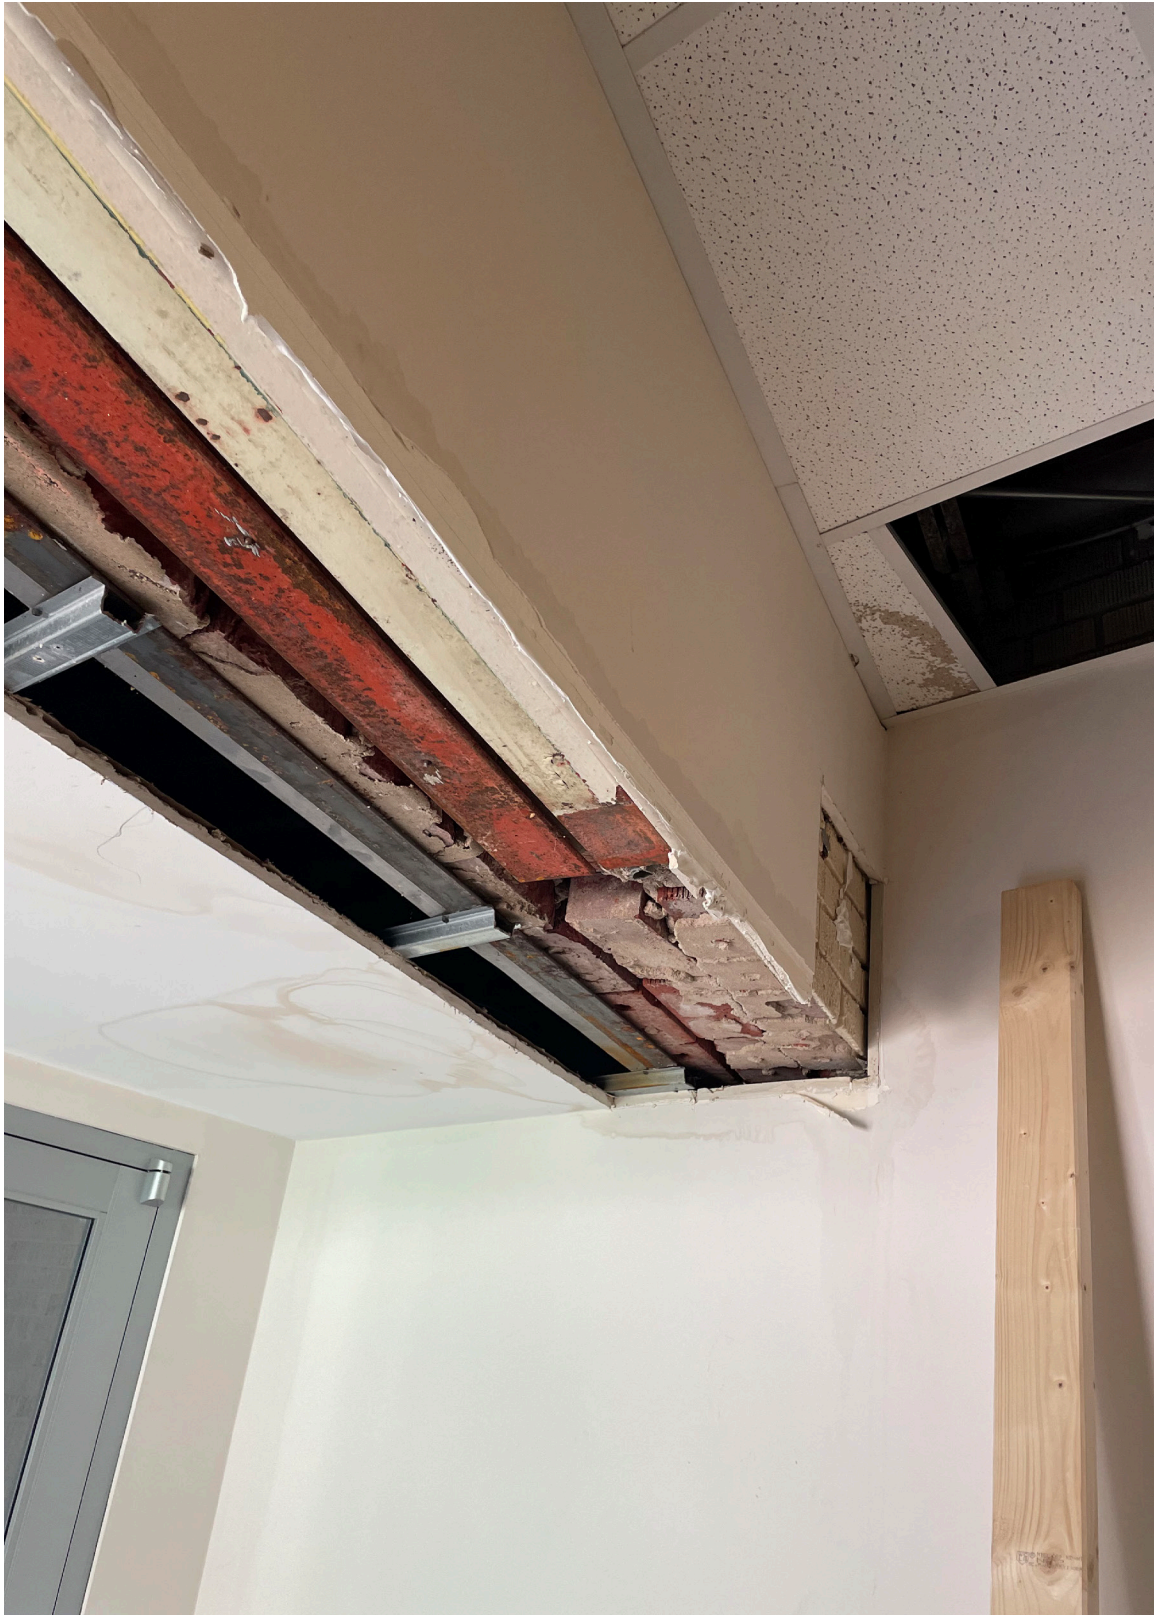
Figure 33: Weldon Auditorium: Additional view of existing orange steel lintel and unsupported masonry.
