PHASE I ENVIRONMENTAL SITE ASSESSMENT
± 3-ACRE PROPOSED TURBEVILLE FIRE STATION NO. 2
CLARENDON COUNTY, SOUTH CAROLINA

Prepared For:
Clarendon County
411 Sunset Drive
Manning, South Carolina 29102

Prepared By:
Alliance Consulting Engineers, Inc.
Post Office Box 8147
Columbia, South Carolina 29202

Project No. 23145-0014

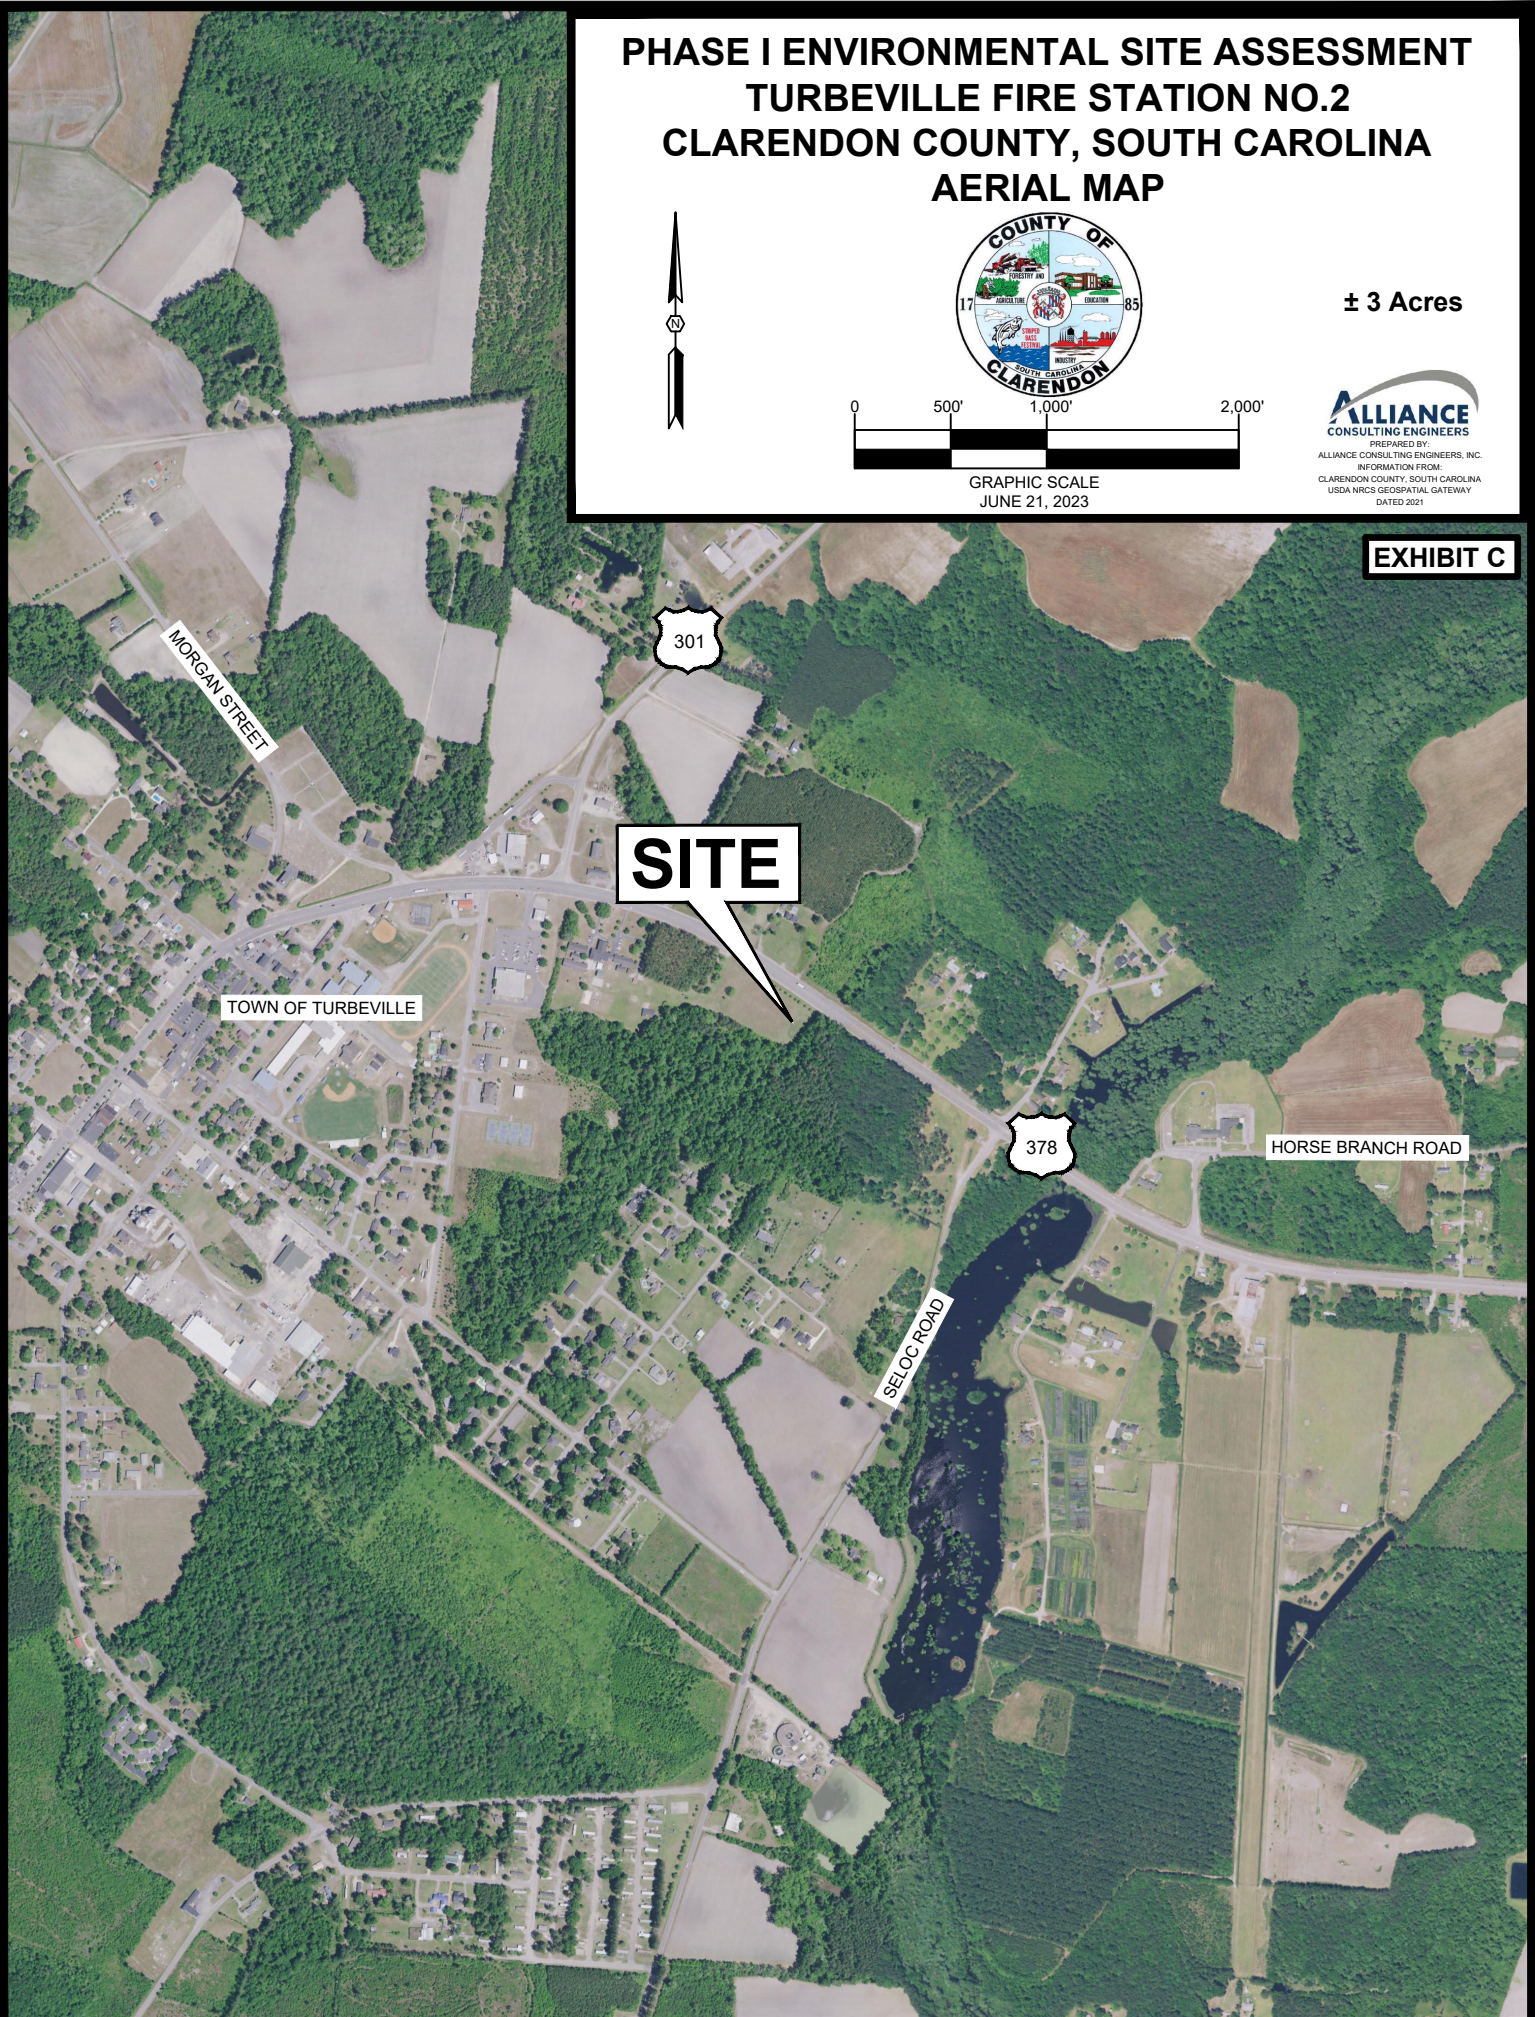
EXHIBIT D

PHASE I ENVIRONMENTAL SITE ASSESSMENT TURBEVILLE FIRE STATION NO.2 CLARENDON COUNTY, SOUTH CAROLINA TOPOGRAPHICAL MAP

GRAPHIC SCALE
CONTOUR INTERVAL 5 FEET
JUNE 21, 2023

The *subject property* is comprised of negligible slopes. The precise direction of groundwater flow is a parameter that is not always easily discernible for a particular site and is beyond the scope of this assessment. A USGS Topographic Map dated 2020 (Exhibit D) was used to characterize suspected drainage patterns on the *subject property*. Based on the topography of the *subject property*, it is believed that stormwater will meander south and east toward Horse Branch.
