**PHASE I ENVIRONMENTAL SITE ASSESSMENT**

**± 10-ACRE PROPOSED EMERGENCY ON CALL 911 CENTER**

**CLARENDON COUNTY, SOUTH CAROLINA**

Project No. 23143-0014

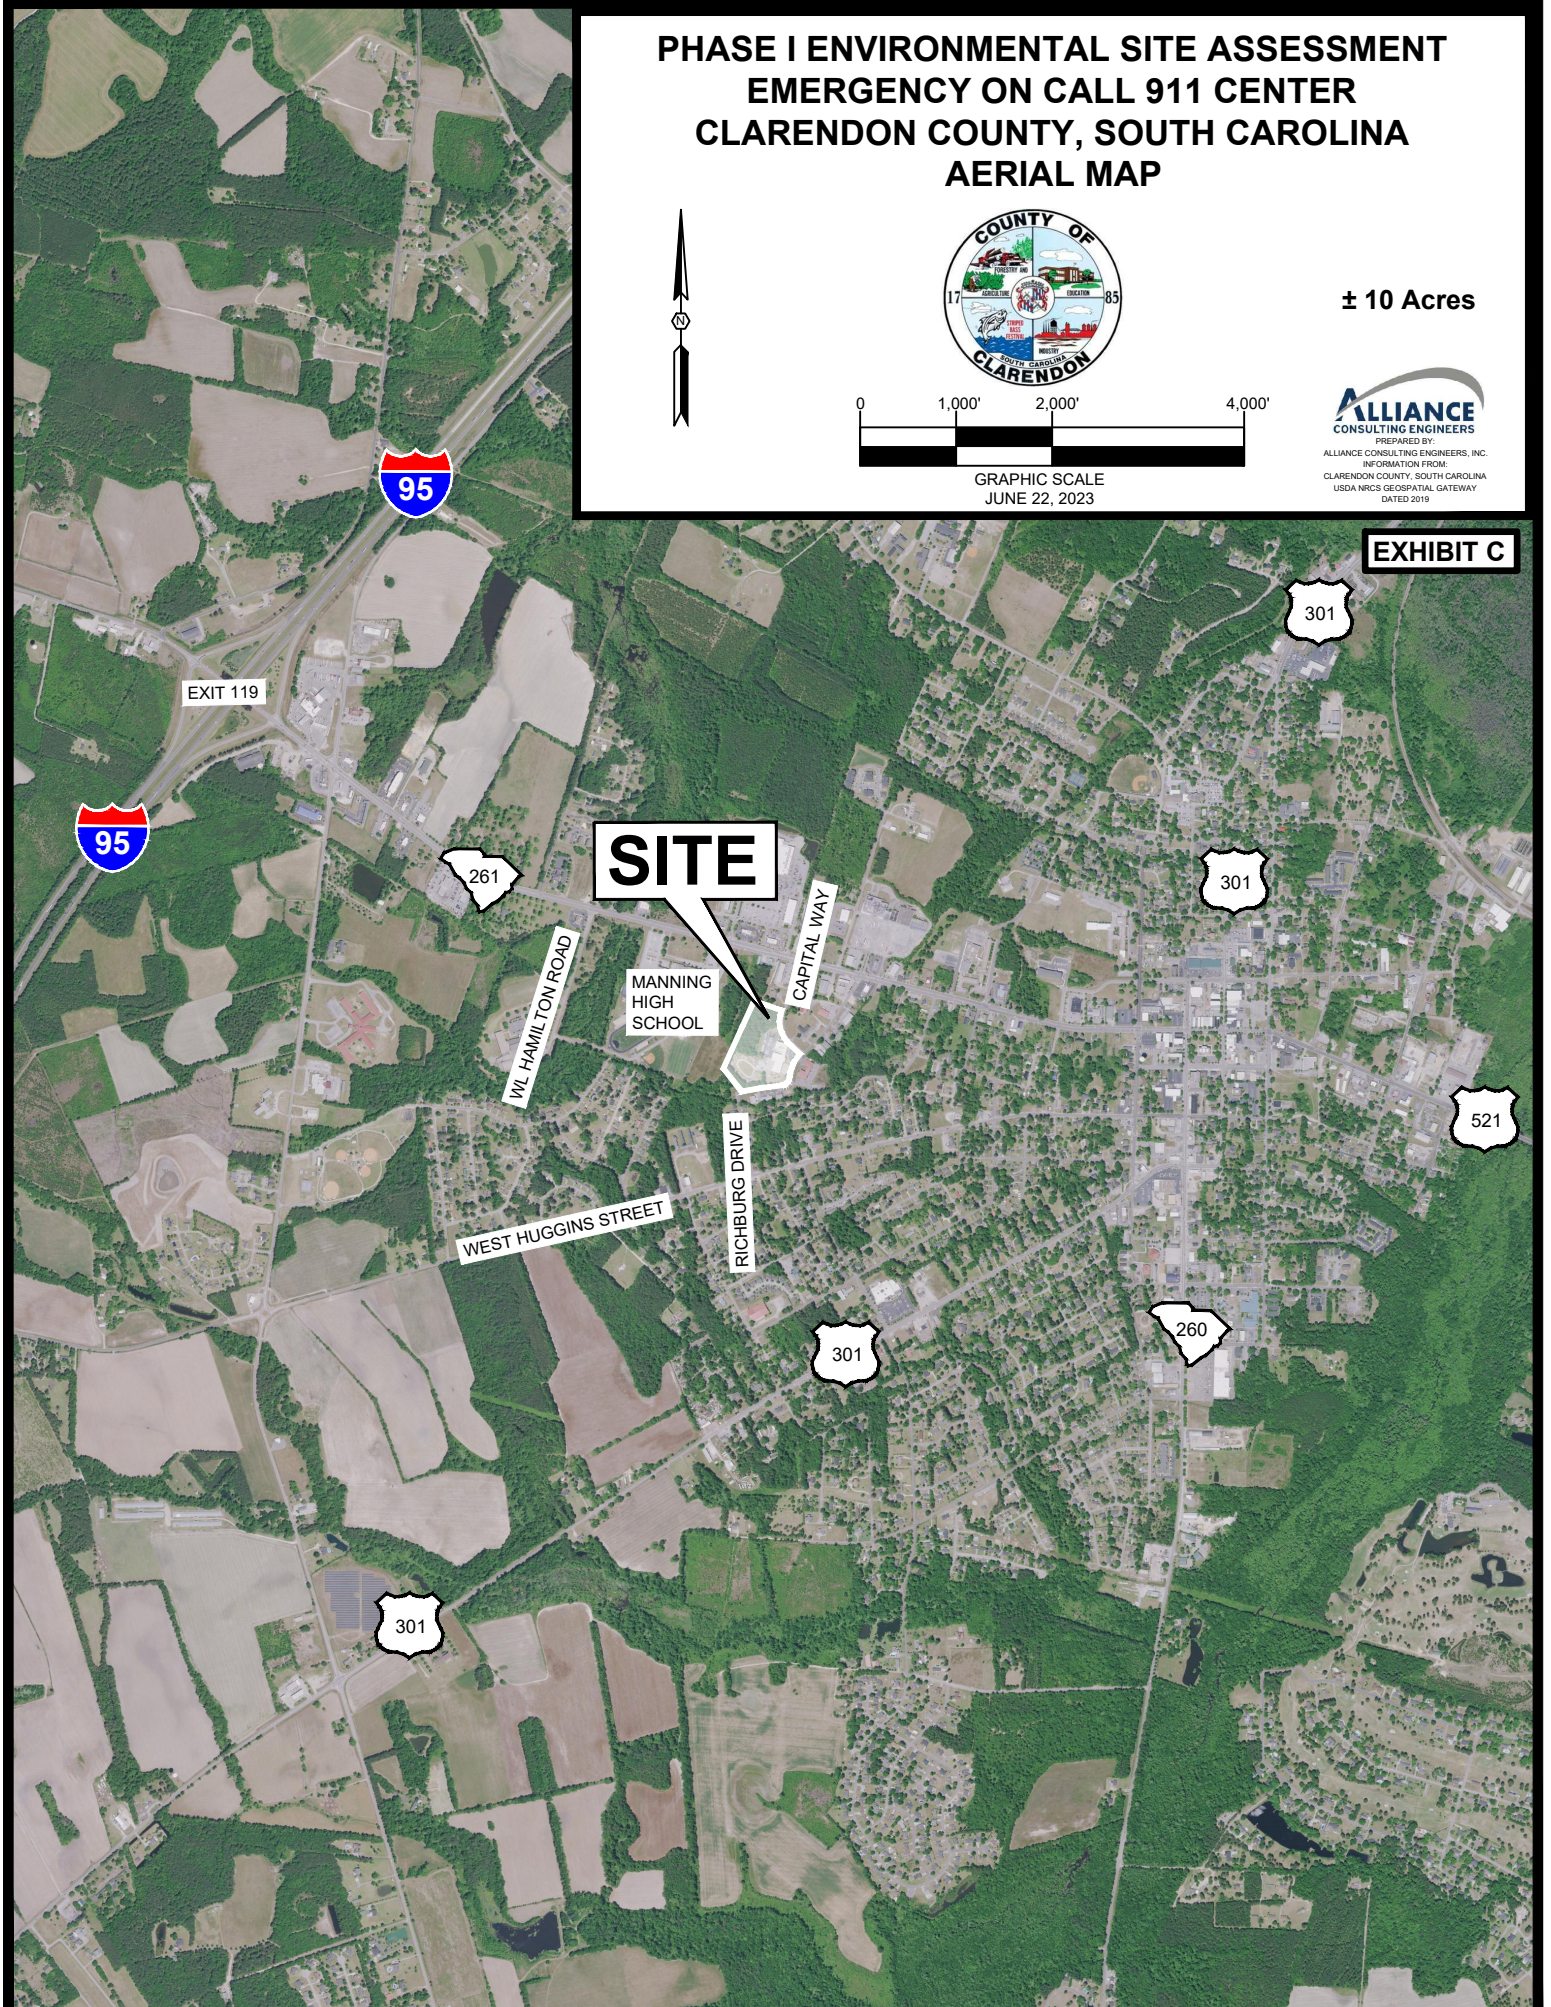
**EXHIBIT D**

PHASE I ENVIRONMENTAL SITE ASSESSMENT  
EMERGENCY ON CALL 911 CENTER  
CLARENDON COUNTY, SOUTH CAROLINA  
TOPOGRAPHIC MAP

GRAPHIC SCALE:  
CONTOUR INTERVAL 5 FEET  
JUNE 22, 2023

The *subject property* is comprised of negligible slopes. The precise direction of groundwater flow is a parameter that is not always easily discernible for a particular site and is beyond the scope of this assessment. A USGS Topographic Map dated 2020 (Exhibit D) was used to characterize suspected drainage patterns on the *subject property*. Based on the topography of the *subject property*, it is believed that stormwater will flow slowly west toward Bell Branch.

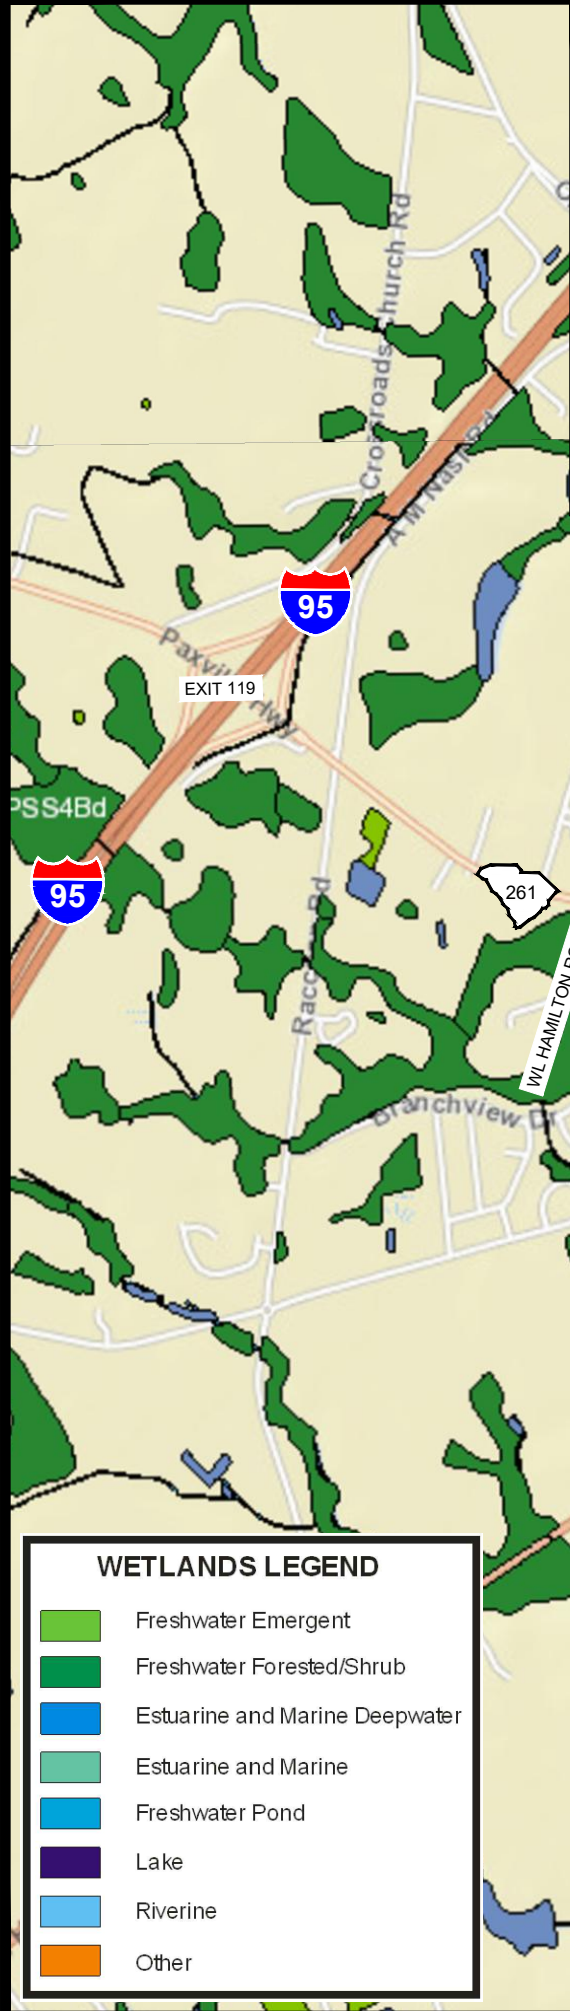
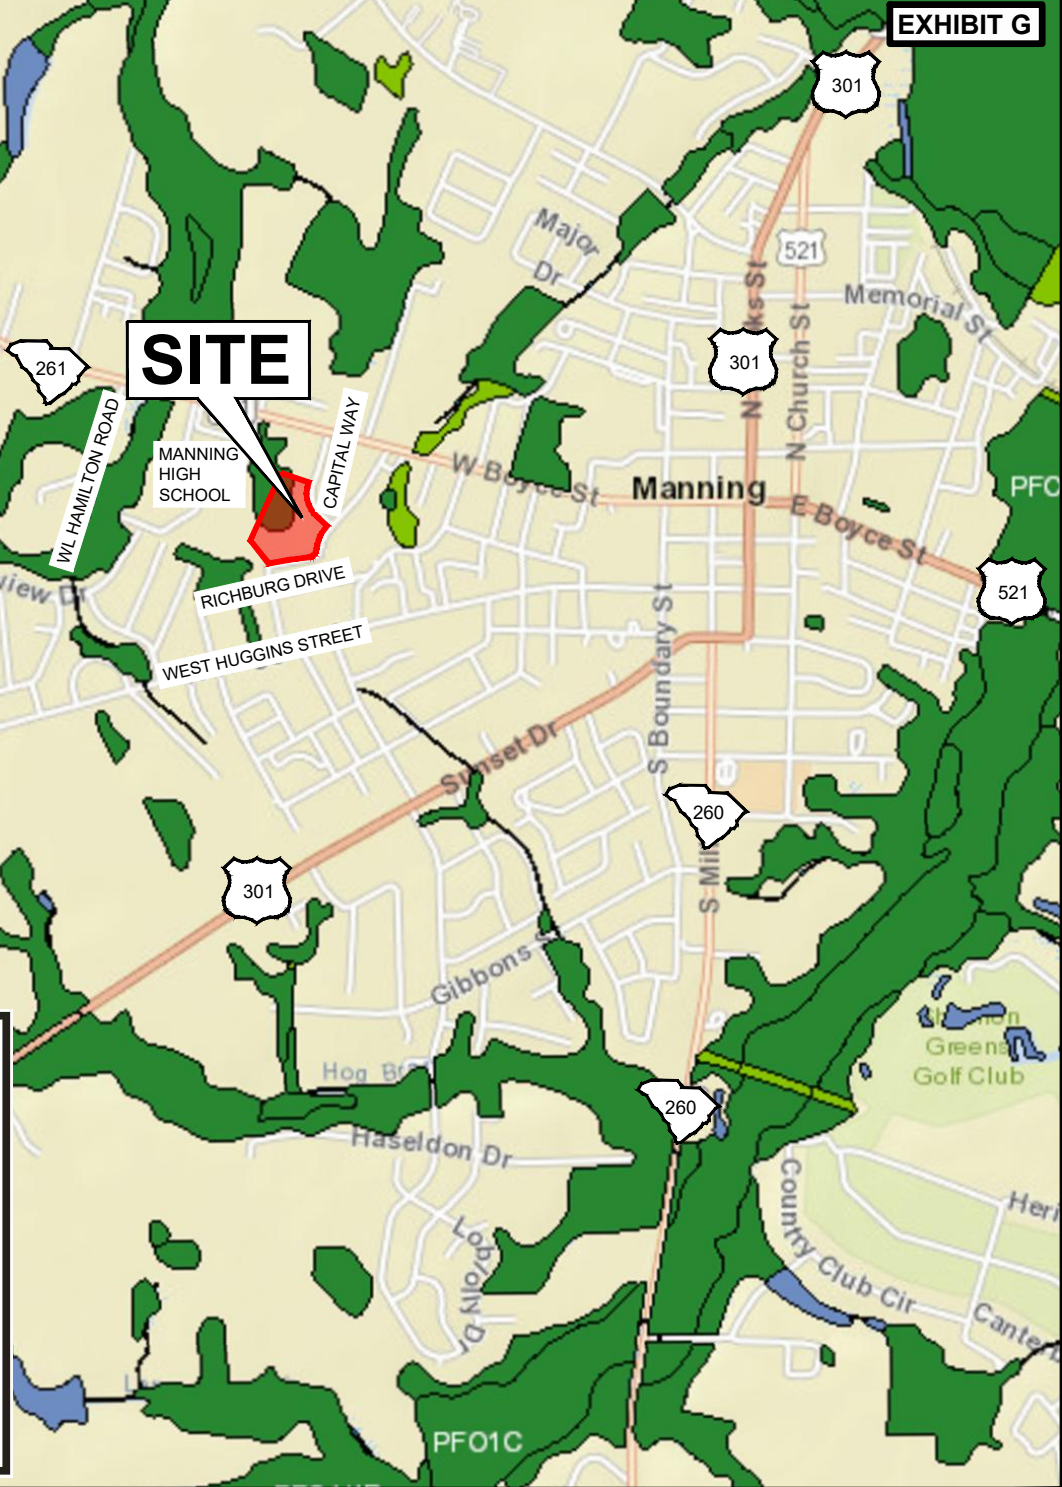
**EXHIBIT G**

**PHASE I ENVIRONMENTAL SITE ASSESMENT  
EMERGENCY ON CALL 911 CENTER  
CLARENDON COUNTY, SOUTH CAROLINA  
NATIONAL WETLANDS INVENTORY(NWI) MAP**

**WETLANDS LEGEND**

(Exhibit G) indicates a small area of potential Freshwater Forested/Shrub wetlands on the subject property. Per the Clarendon County Soil Survey (Exhibit E), the subject property is comprised of Clarendon (Cd), Dothan (DoA) and Rains (Ra) series soils. Clarendon and Dothan series soils are of Hydraulic Soil Group (HSG) B. Soils in HSG B are moderately drained with moderate permeability. Rains series soils are of HSG A/D. Soils in HSG A are well drained with high permeability and soils in HSG D have very poor drainage with very slow permeability and are typically shallow over nearly impervious material. Dual class soils follow the drainage and permeability of their first HSG group when present in drained locations. Only soils in HSG D in their natural condition are assigned to dual classes. Since perimeter soil characteristics are neither conducive nor restrictive of passage of contaminants to the subject property due to average drainage, it is unlikely that soil composition will have much bearing on whether contaminants from off-site locations will impact the subject property.
